Korenix JetNet Industrial Managed Switch 5010G SOFTWARE RELEASE Notes

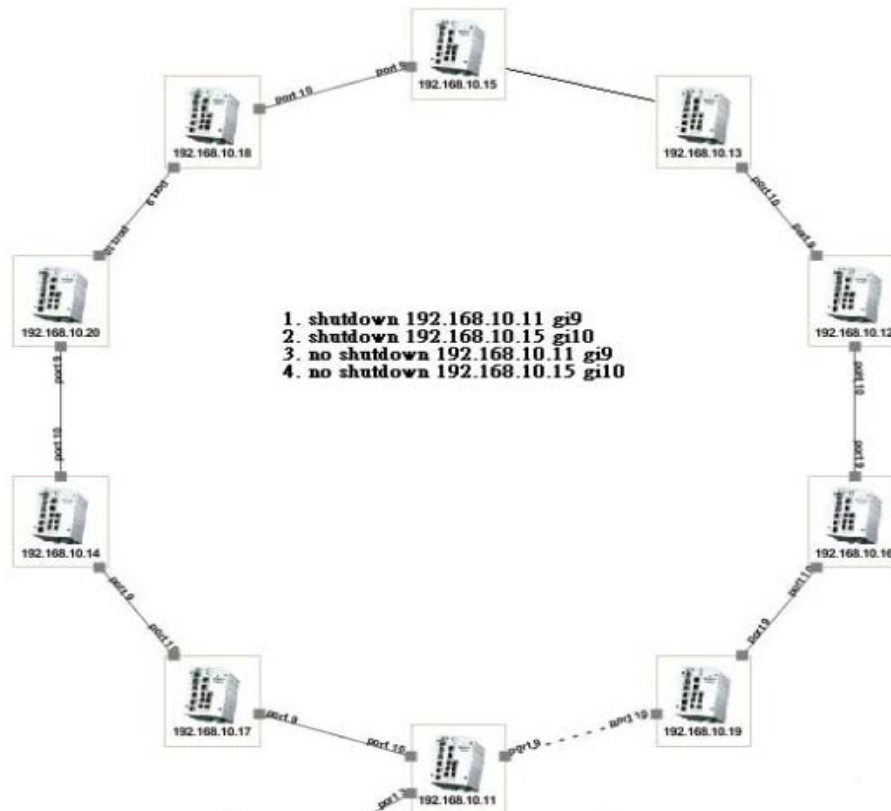
- Super Ring v2 can't run with LLDP function. (#1142)
- As the ring topology as below, link down /up active ring path will cause the ring status show "Abnormal" when this architecture working with JetView Pro for 2 days, also one of DUT will not be discovery by JetView Pro utility (# 1143,1144)

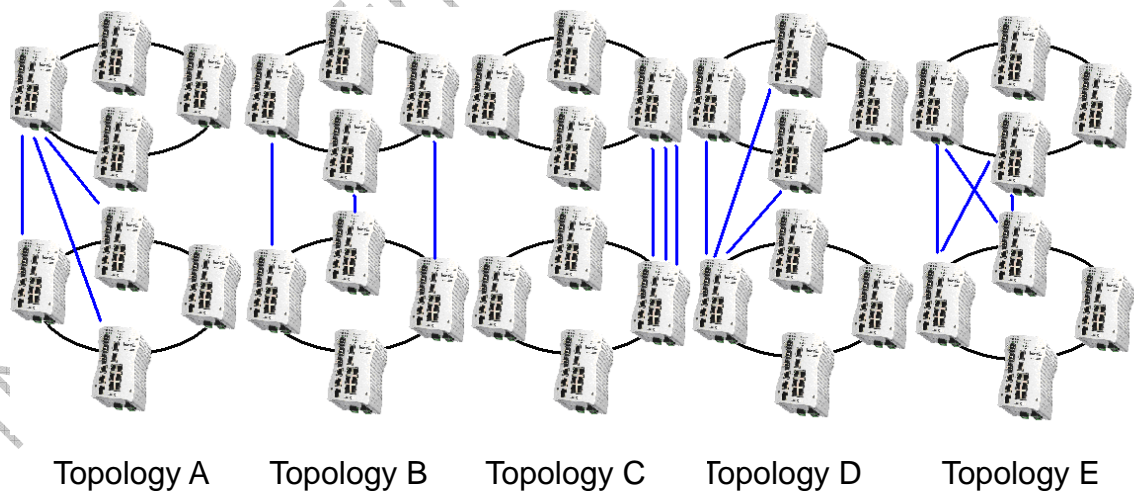
- Recovery time of node down in topology B and D is over than 1 sec (# 1016), see attached diagram as following.
