## Korenix JetNet Industrial Managed Switch 5010G SOFTWARE RELEASE Notes

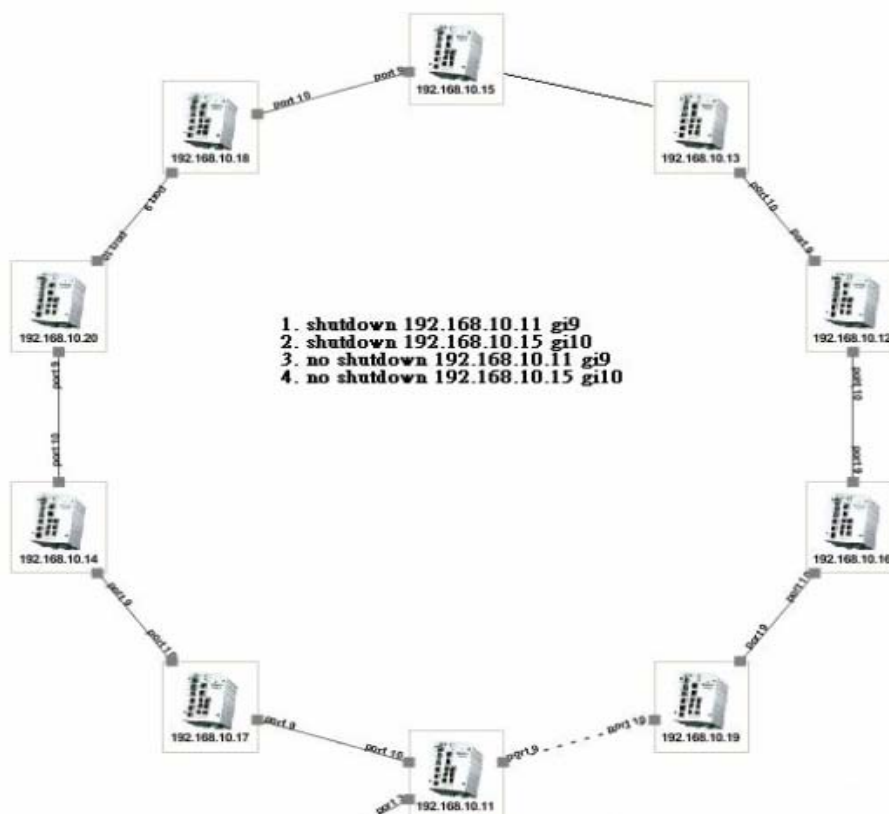
- Super Ring v2 can't run with LLDP function. (#1142)
- As the ring topology as below, link down /up active ring path will cause the ring status show "Abnormal" when this architecture working with JetView Pro for 2 days, also one of DUT will not be discovery by JetView Pro utility (# 1143,1144)

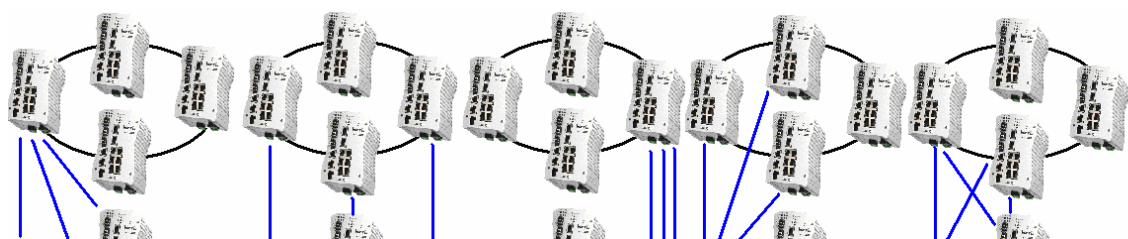
- Recovery time of node down in topology B and D is over than 1 sec (# 1016), see attached diagram as following.
