Korenix JetNet Industrial Managed Switch JetNet 5008G-P SOFTWARE RELEASE Notes

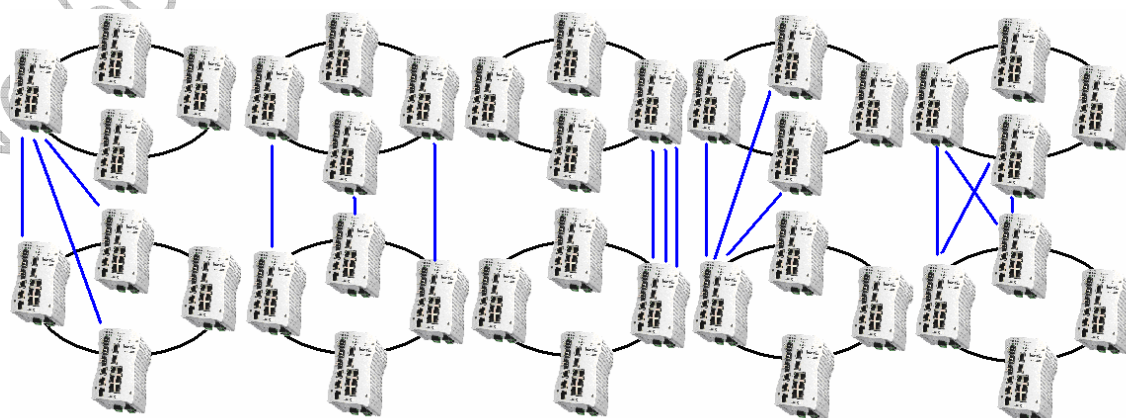
- In the SNMP management mode, the DUT does not restrict aggregate port as trunk group when one is 802.1x enabled.(# 1008).
- Recovery time of node down in topology B and D is over than 1 sec (# 1016), see attached diagram as following.
