## Korenix JetNet Industrial Managed Switch JetNet 4510 SOFTWARE RELEASE Notes

Firmware Version	Boot Loader Version	Release Date	Model
V2.0	V1.6.2.10	Jan. 9, 2008	Official release for JetNet 4510
V2.1	V1.6.2.10	21, Apr, 2008	Official release for JetNet 4510

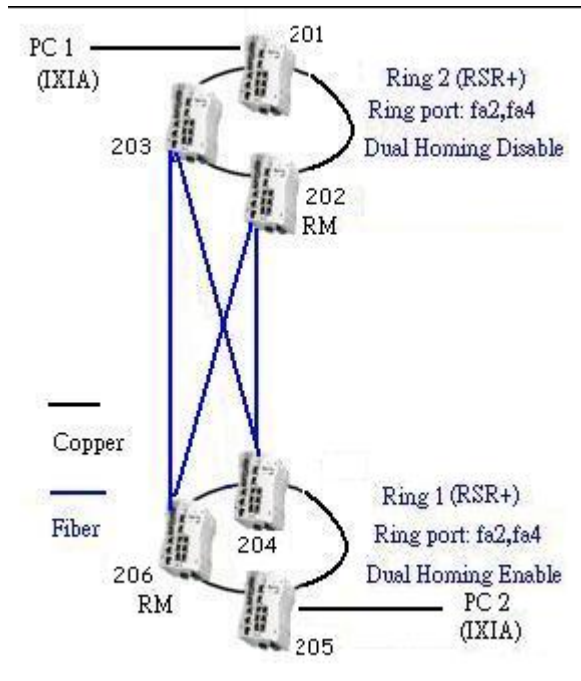
- In version V2.1 firmware, if disable and delete the ring setting by Web interface, the SNMP MIB browser won't present exactly configuration.
- The combo port does not support fiber link-up first function when transceiver is 100Mbps multi-mode type.
- In Web interface, JetNet 4510 can configure GVRP function before Trunk port build and connected. But, it can't support in command line interface.
- The rate limiting or shaping function could not be applied on trunk port, since the speed of trunk port should be same.
- In dual homing architecture, only provide 7 uplink paths. If uplink path over 7 will cause video stream abnormal.
- In following network architecture, if plug out the any path either device 203 and 206 or device 202 and 204 will result the connection break down. This testing result only present in one-way ping command testing.

- As the upper ring architecture, when we do device power-down and the recovery time will exceed 1 sec and the traffic will be duplicated.
- If change IP address of IGMP querier, the JetNet 4510 won't change it immediately.
- It does not pop-up warning information when set rate limiting or shaping on trunk port. Since, the trunk port should be full wire speed and could not be limited.
- It won't pop-up warning information and restrict when configure dot1x function into Trunk group by SNMP interface.
- In RSTP inter-operability testing, if change Root Switch between Cisco 2950 switch and JetNet 4510 switch will cause JetNet 4510 non-edge port looping and changes to forwarding mode.
- The Recovery time of DUT power-off testing will take more than 1 sec.
