## Korenix JetNet PoE Switch- JetNet 3706 SOFTWARE RELEASE Notes

Firmware Version	Boot Loader Version	Release Date	Note
V 1.0	V1.6.4.1	Oct. 2, 2007	Official release
V 2.0	V1.6.4.2	Nov. 28, 2007	Official release
V 2.1	V1.6.4.3	Apr, 16, 2008	Official release

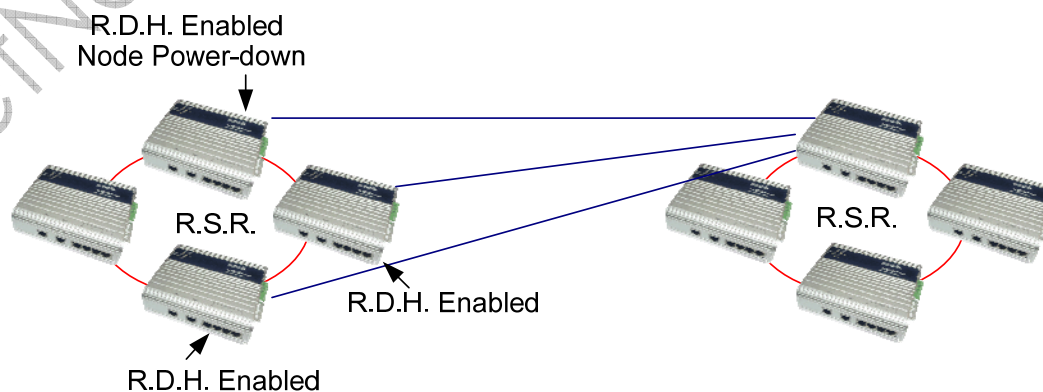
- Boot loader v1.6.4.3 should use firmware 2.1 or above.
- The system can't downgrade to V1.0 after upgrade to version 2.1.
- In the ring topology, the recovery time of node power-up is around 30 seconds.
- In the RSTP interoperability testing case- JetNet 3706 connects 3 paths to Cisco 2950. It will cause uplink port state change to forwarding mode and start looping when Root Switch changes from JetNet 3706 to Cisco 2950.
- As following topology, the node ( R.D.H. enabled) power-down recovery time may take over 1 sec.

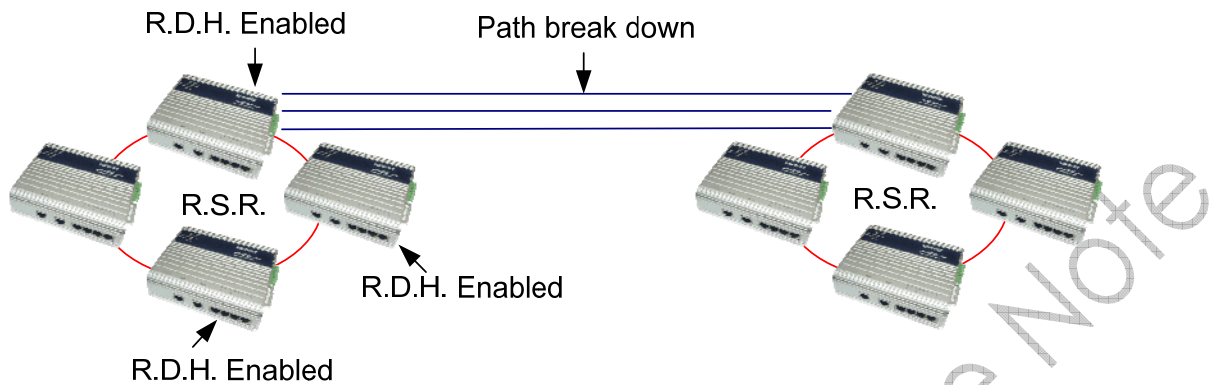
- As following topology, when plugged-out the link path will cause the packet duplicated between 2 rings.
