## Korenix JetNet Industrial Managed Switch 4510 SOFTWARE RELEASE Notes

### About This Software Version

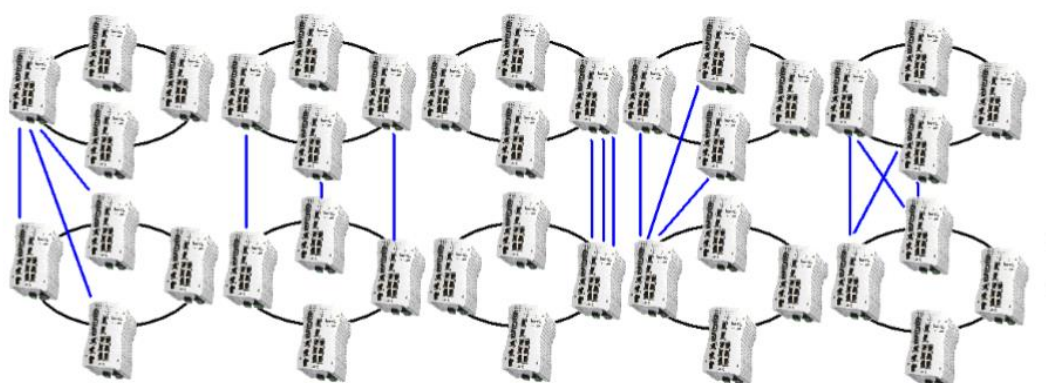
Topology A    Topology B    Topology C    Topology D    Topology E

- The querier can't auto election when DUT connect with Cisco Switch. (# 1110)
- As the ring topology as below, link down /up active ring path will cause the ring status show "Abnormal" when this architecture working with JetView Pro for 2 days, also one of DUT will not be discovery by JetView Pro utility (# 1143,1144)
