Test Report

EN 50155: 2007

(Clause 12.2.11 Vibration, shock and bump test)

Product : **Ethernet Switching Hub**

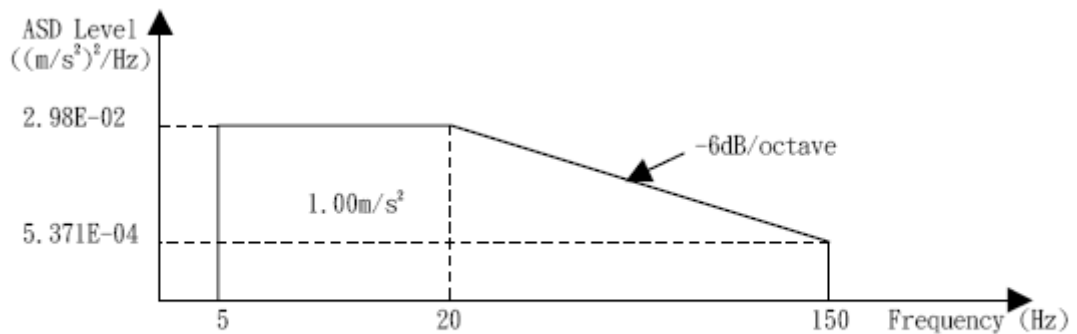
G_{rms} value: Vertical (Z-Axis) 1.00m/s^2

PSD of Vertical (Z) Axis

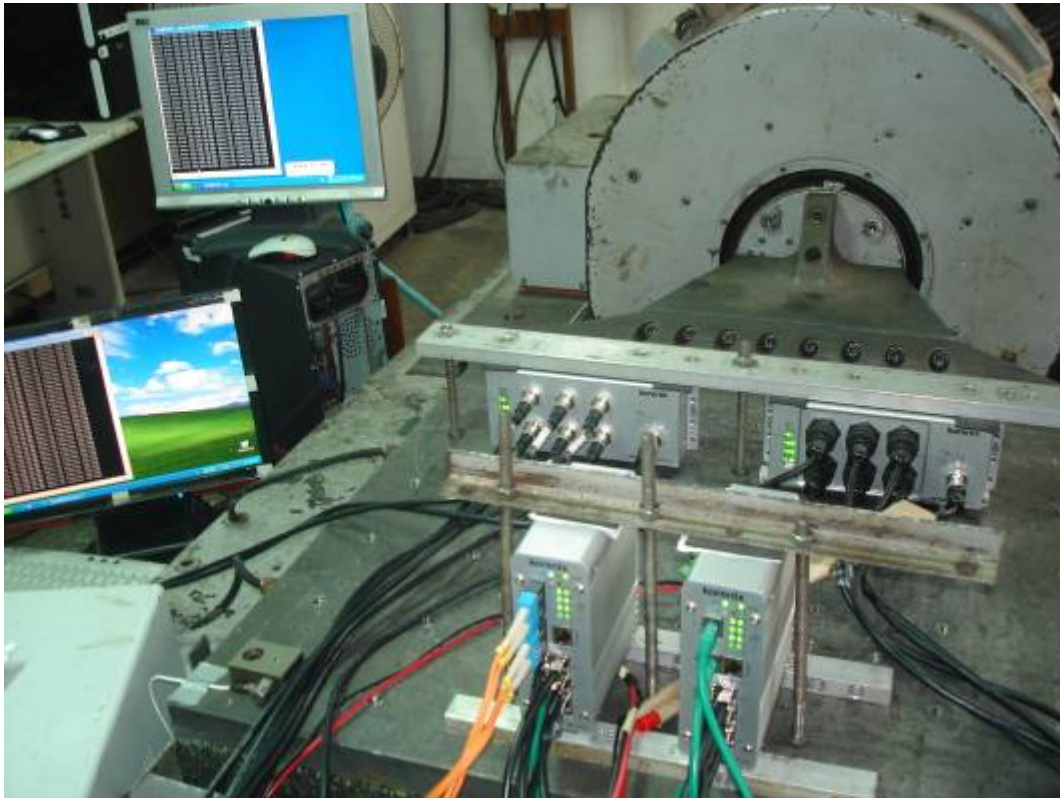
Fig. 1: Vibration Test in X-Axis

1. Test configurations are shown in Fig.1~Fig.3.
2. The testing data are shown in Fig.4~Fig.6.
3. Test specimen was visually inspected after test. No external physical damage was noted.
4. The function of specimen was normal during and after the vibration test.

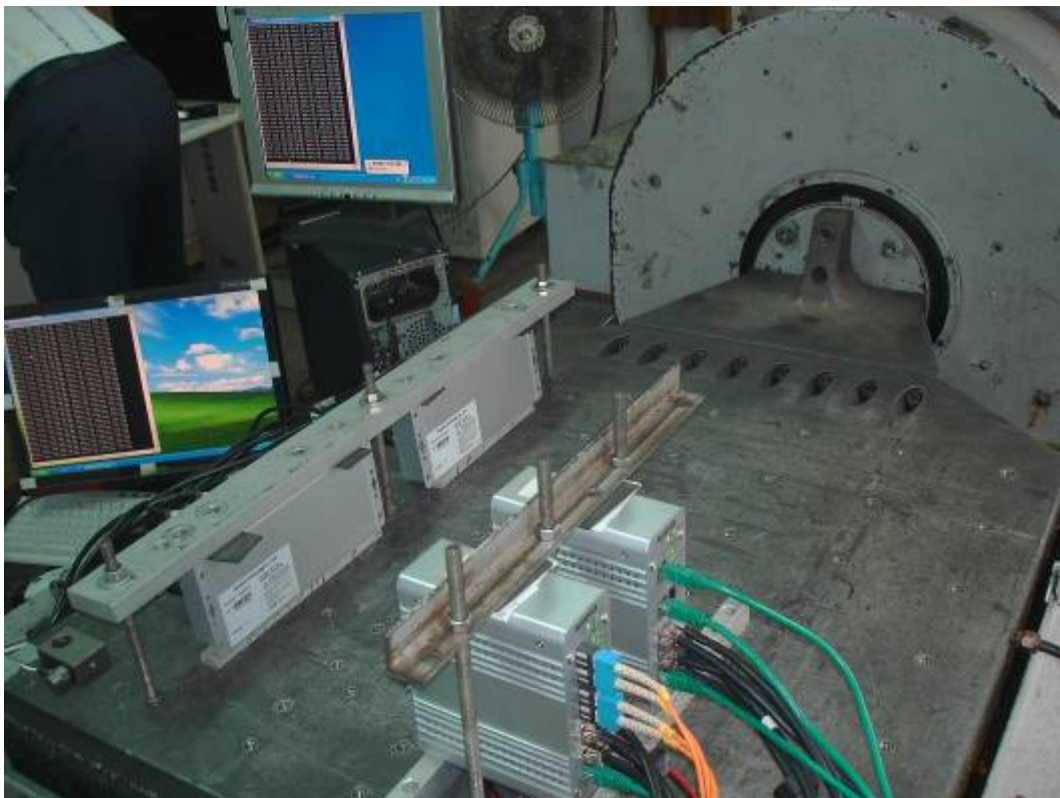
Fig. 2: Vibration Test in Y-Axis

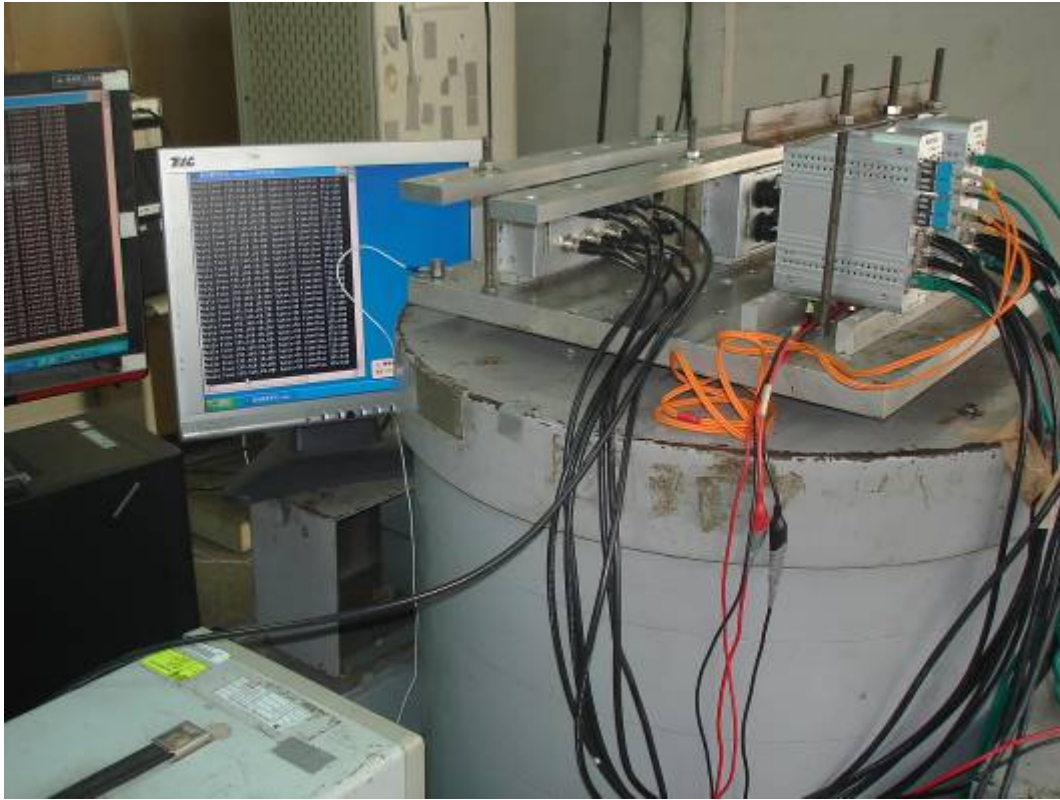
Fig. 3: Vibration Test in Z-Axis

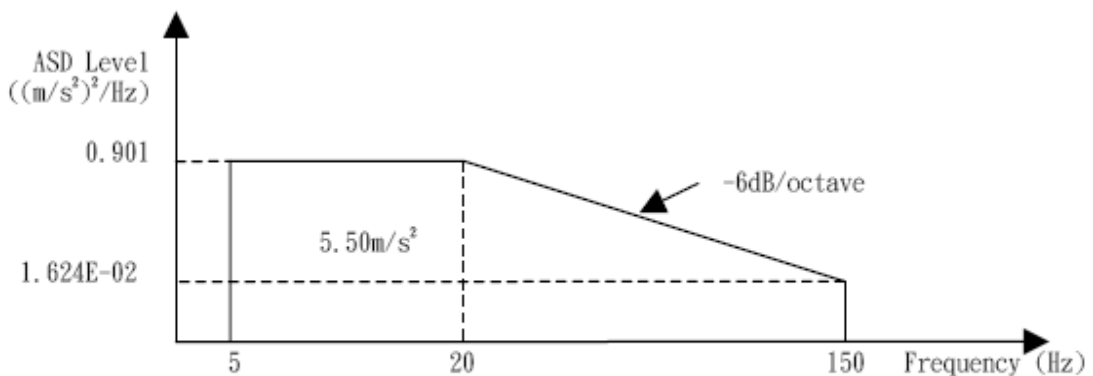
Transverse (Y-Axis) 5.50m/s^2

Longitudinal (X-Axis) 5.50m/s^2

PSD of Longitudinal (X) Axis and Transverse (Y) Axis

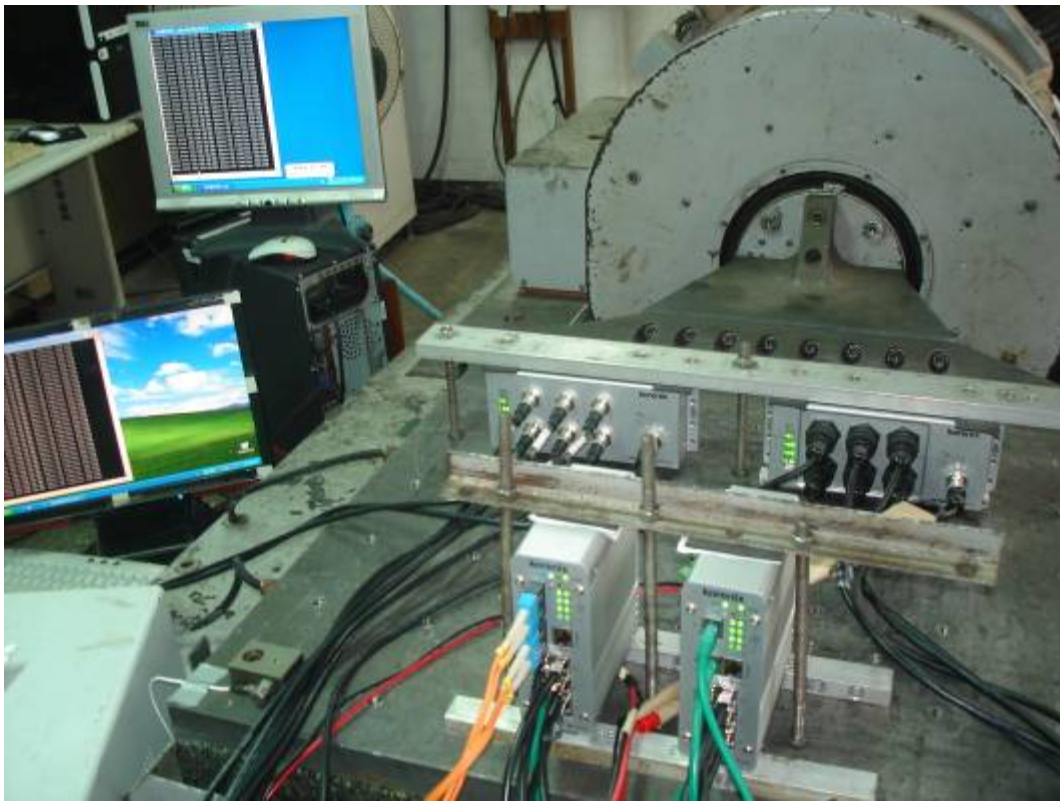
Fig. 1: Increased Vibration test in X-Axis

1. Test configurations are shown in Fig.1~Fig.3.
2. The testing data are shown in Fig.4~Fig.6.
3. Test specimen was visually inspected after test. No external physical damage was noted.
4. The function of specimen was normal after the increased vibration test.

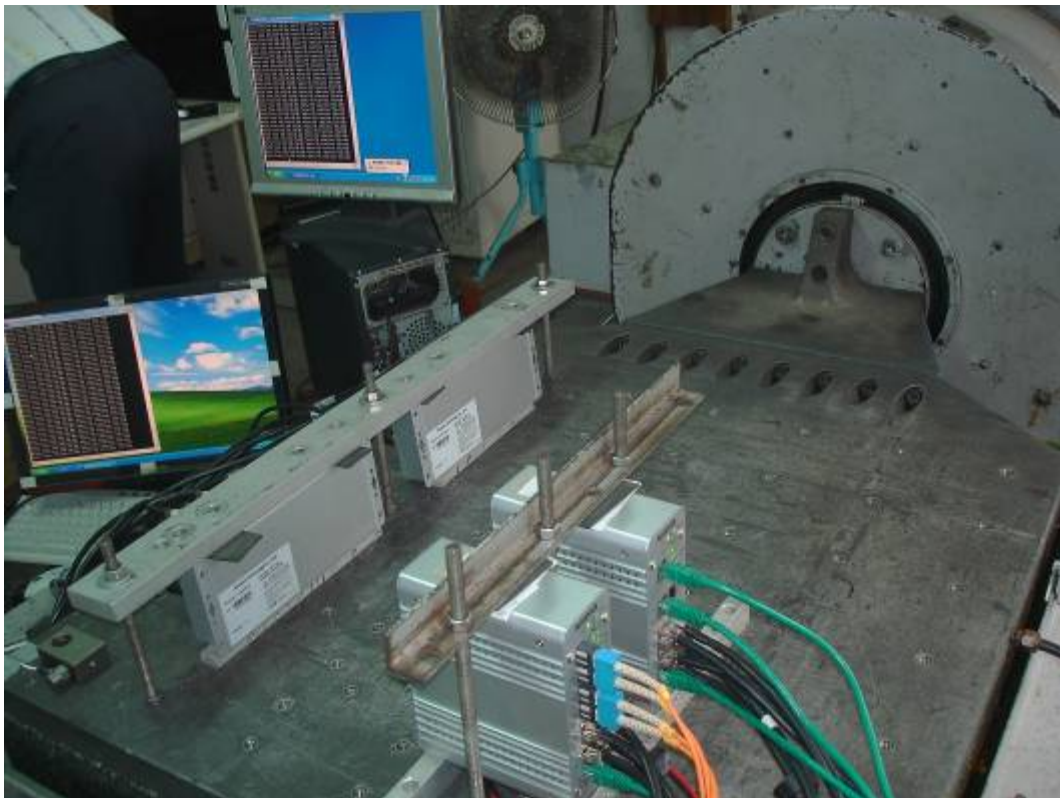
Fig. 2: Increased Vibration test in Y-Axis

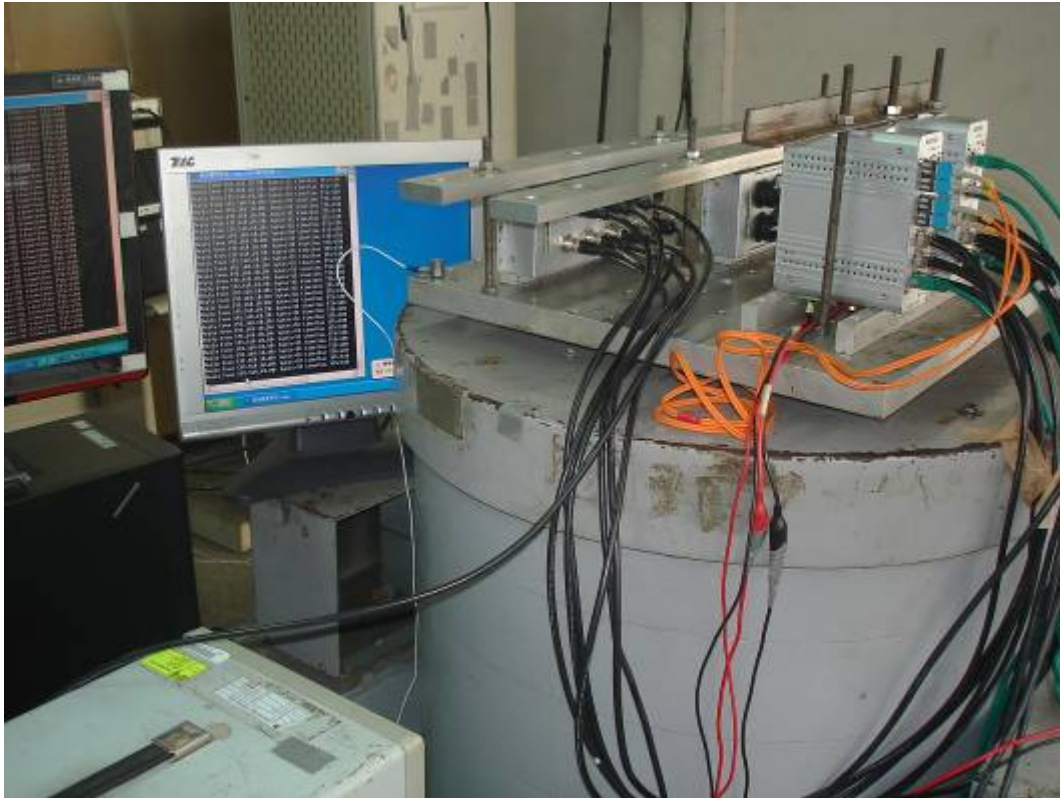
Fig. 3: Increased Vibration test in Z-Axis

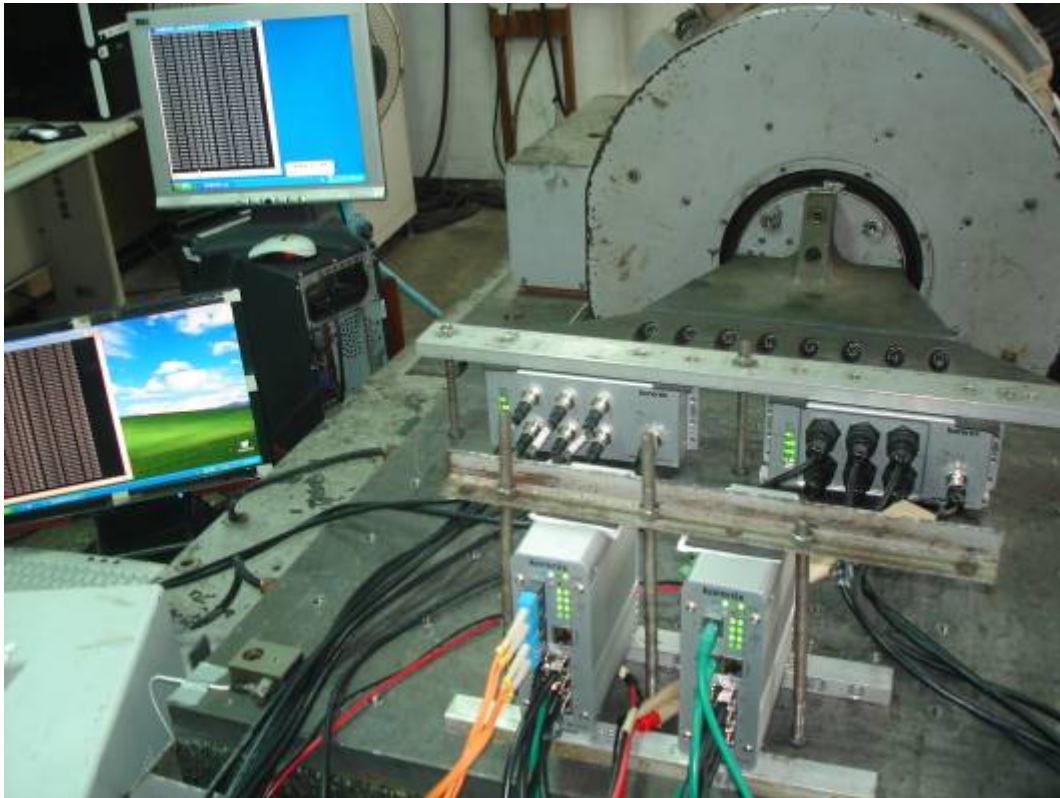
Fig. 1: Shock Test in X-Axis

1. Test configurations are shown in Fig.1~Fig.3.
2. The testing data are shown in Fig.4~Fig.9.
3. Test specimen was visually inspected after test. No external physical damage was noted.
4. The function of specimen was normal during and after the shock test.

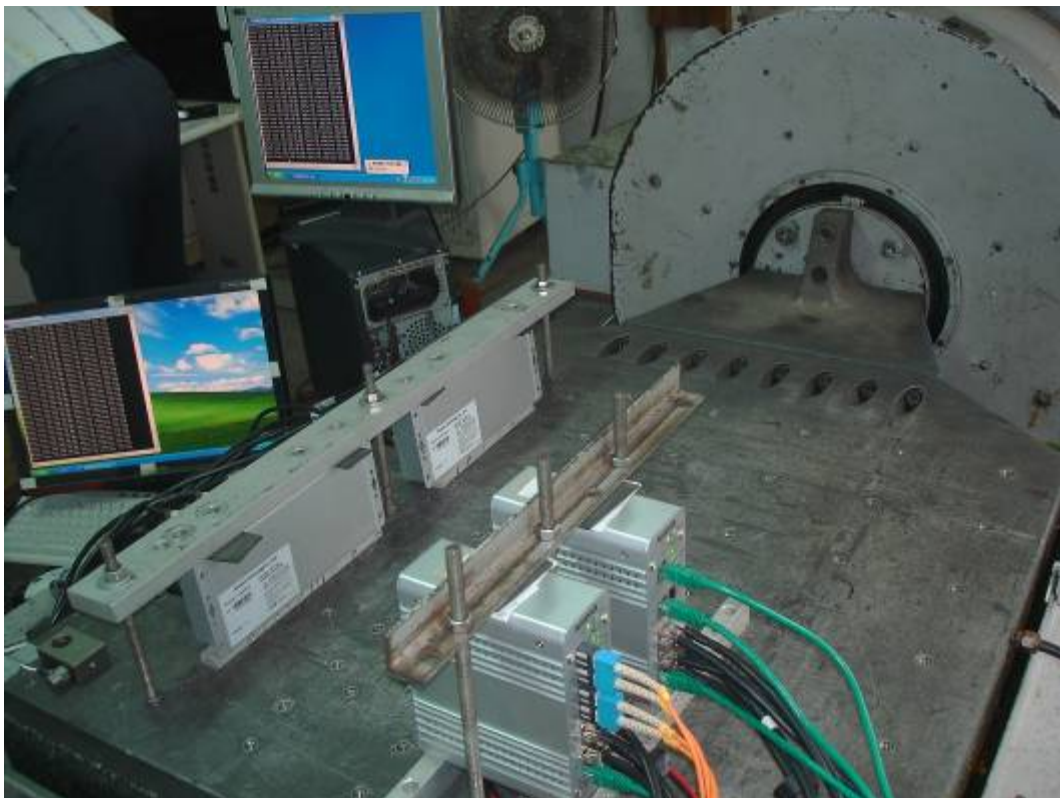
Fig. 2: Shock Test in Y-Axis

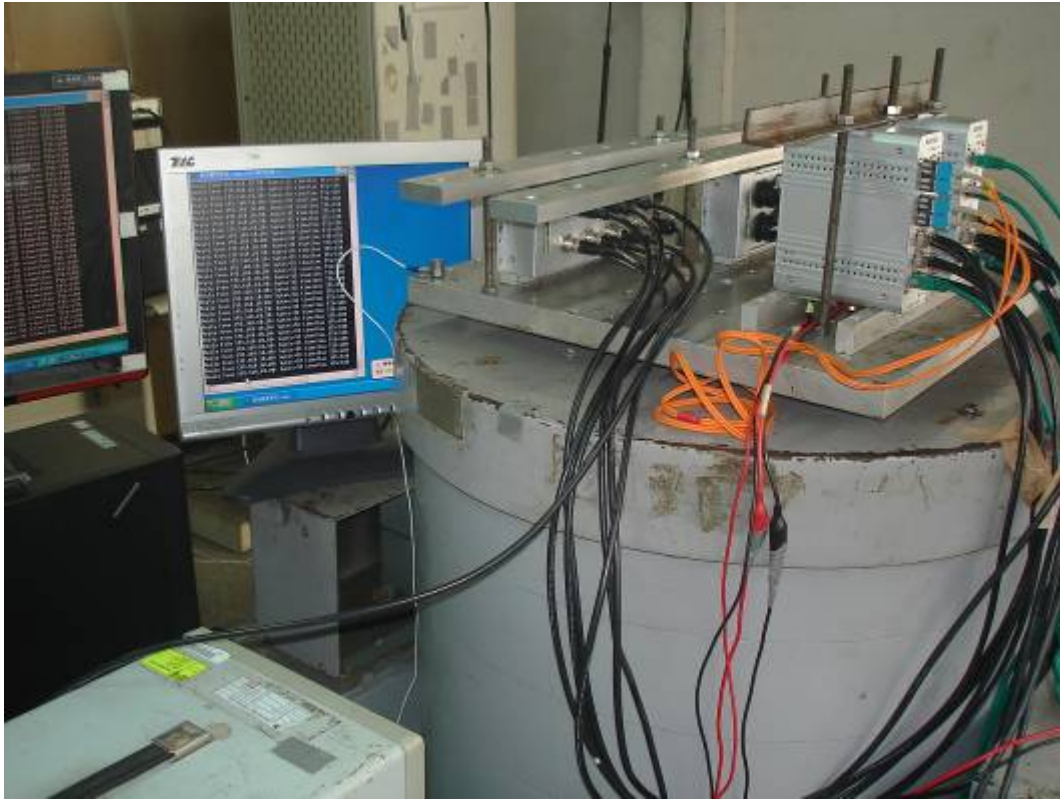
Fig. 3: Shock Test in Z-Axis

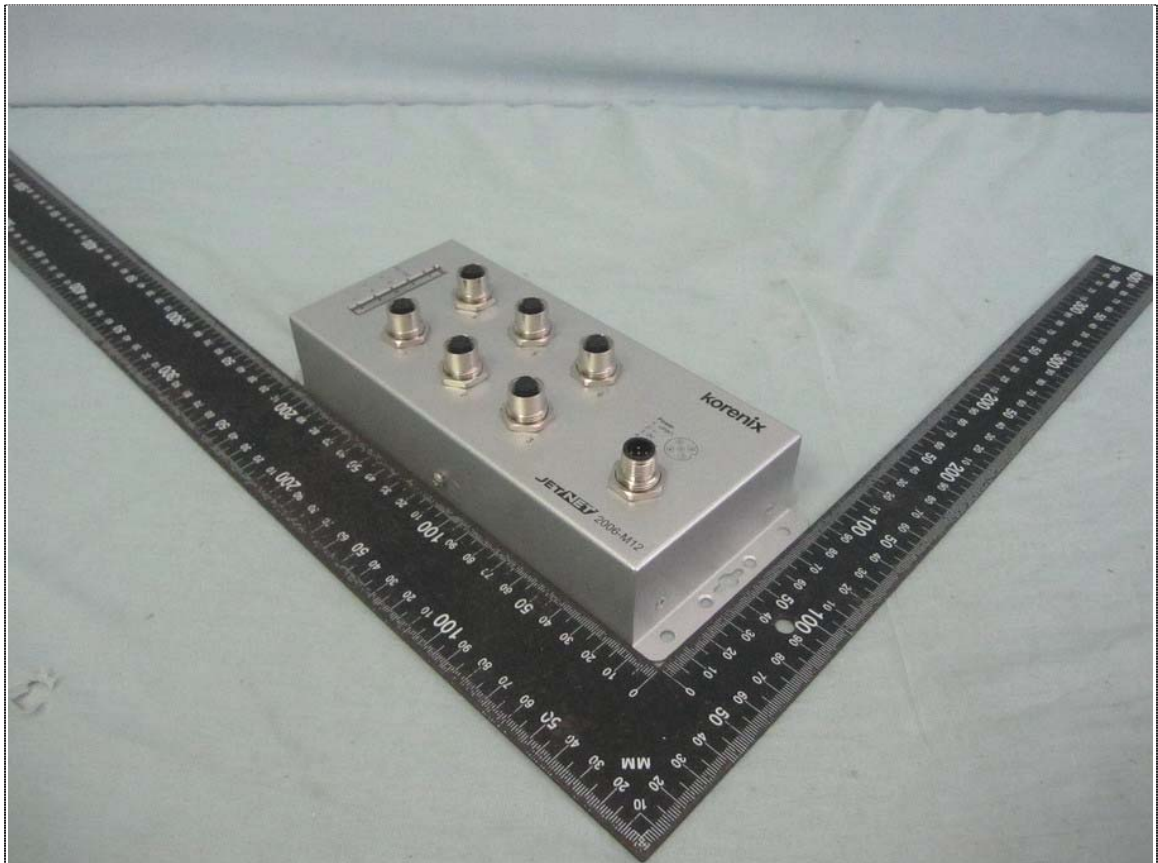
Front View of EUT

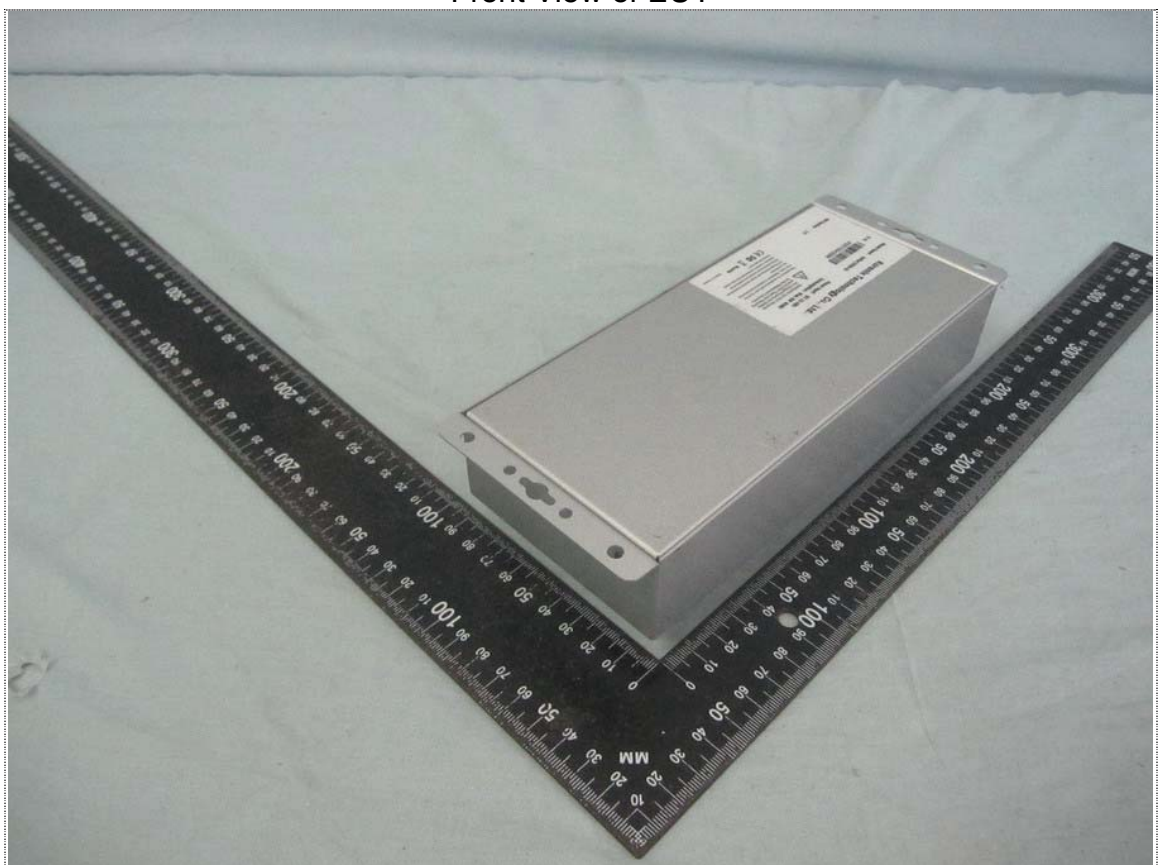
Rear View of EUT
