## Korenix JetNet PoE Switch- JetNet 4706f SOFTWARE RELEASE Notes

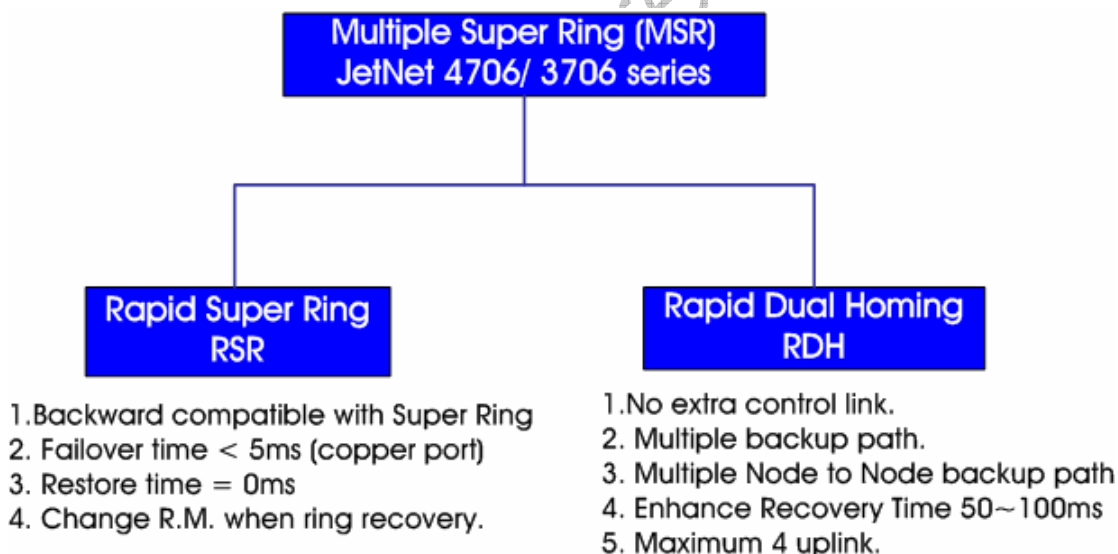
- Support Multiple Super Ring function (M.S.R.) which include enhanced Rapid Super Ring (R.S.R.) and Rapid Dual Homing (R.D.H.) functions. The following diagram show the support features.
