Korenix JetNet PoE Switch- JetNet 4706 SOFTWARE RELEASE Notes

About This Software Version

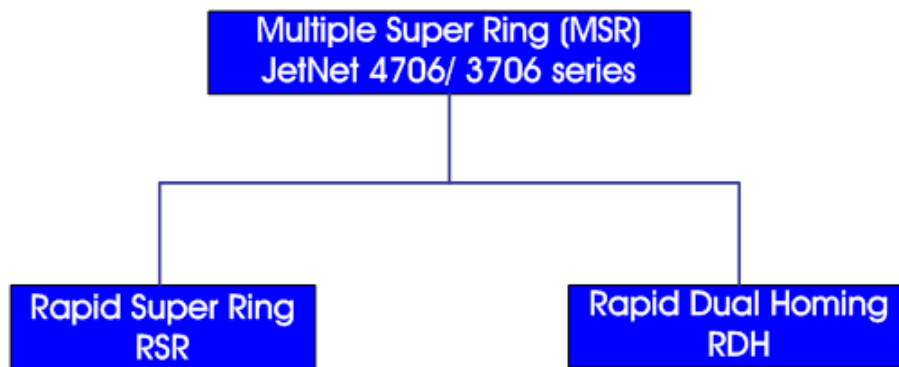
- Support Multiple Super Ring function (M.S.R.) which include enhanced Rapid Super Ring (R.S.R.) and Rapid Dual Homing (R.D.H.) functions. The following diagram show the support features.

1. Backward compatible with Super Ring
2. Failover time < 5ms (copper port)
3. Restore time = 0ms
4. Change R.M. when ring recovery.

1. No extra control link.
2. Multiple backup path.
3. Multiple Node to Node backup path
4. Enhance Recovery Time 50~100ms
5. Maximum 4 uplink.
