## Korenix JetNet Industrial Managed Switch JetNet 5008G-P SOFTWARE RELEASE Notes

### About This Software Version

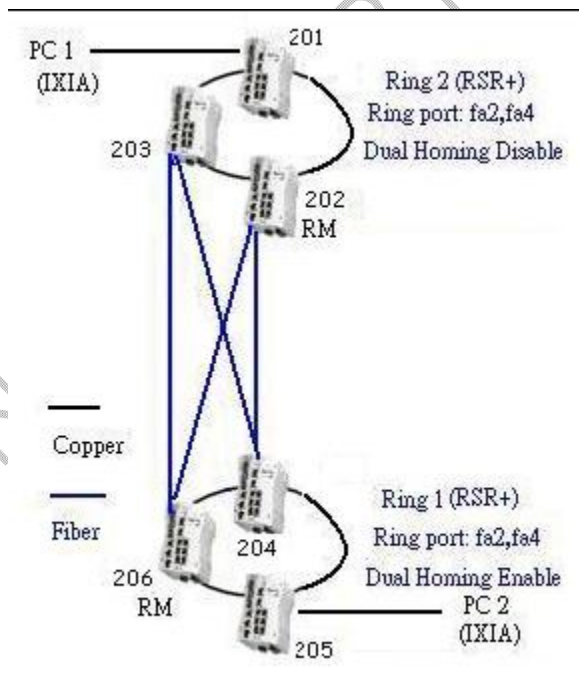
- Important!  
The event alarm relay function only support in hardware version v2.0, hardware version 1.0 does not support v2.0 firmware for event alarm relay.
- Bootloader v1.6.2.10 should use firmware 2.1 or above.
- To apply GVRP function on Trunk group, the trunk port should not link together before apply GVRP function. If apply GVRP function before build the port connection will result GVRP unavailable.
- In dual homing architecture, only provide 7 uplink paths. If uplink path over 7 will cause JetNet 5008G-P working in abnormal.
- In following network architecture, if plug out the any path either device 203 and 206 or device 202 and 204 will result the connection break down. This testing result only present in one-way ping command testing.

- In the ring architecture, if power-on JetNet 5010G which truck ring function is enabled will

cause wrong traffic and the recovery time more than 1 sec.
