## Korenix JetNet PoE Switch- JetNet 4706 SOFTWARE RELEASE Notes

### About This Software Version

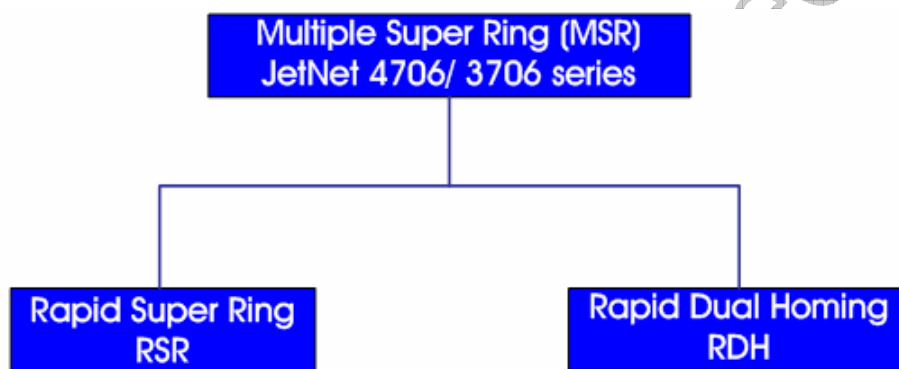
- Support Multiple Super Ring function (M.S.R.) which include enhanced Rapid Super Ring (R.S.R.) and Rapid Dual Homing (R.D.H.) functions. The following diagram show the support features.

1. Backward compatible with Super Ring
2. Failover time < 5ms (copper port)
3. Restore time = 0ms
4. Change R.M. when ring recovery.

1. No extra control link.
2. Multiple backup path.
3. Multiple Node to Node backup path
4. Enhance Recovery Time 50~100ms
5. Maximum 4 uplink.
