Reliability Laboratory

TEST REPORT

Product Description: Industrial Communication Computer

1. Mechanical Shock Test

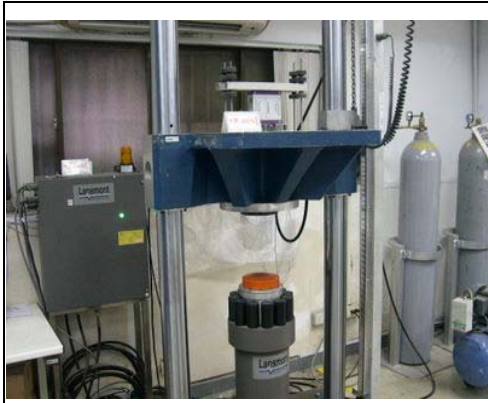
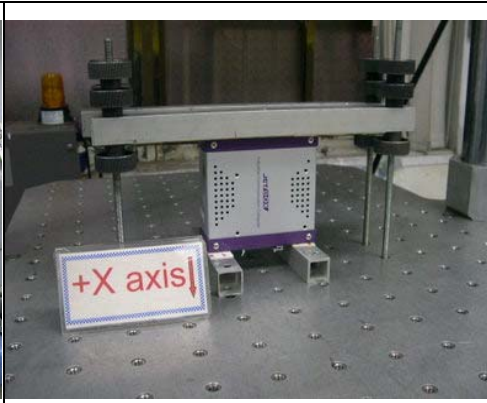
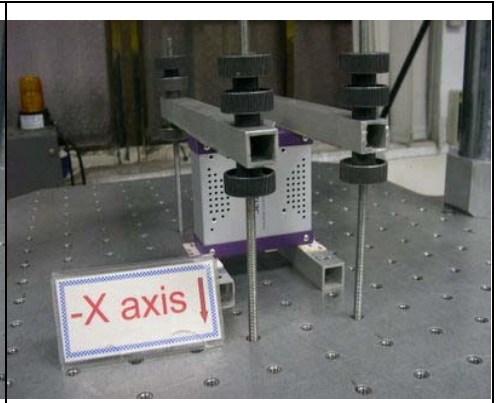
<p>4.Mechanical Shock test: $\pm X$ axis</p>	<p>5.Mechanical Shock test: +X axis</p>	<p>6.Mechanical Shock test: -X axis</p>

Shock direction: 6 faces (±X, ±Y, ±Z axes. See photo 4 ~ 12)

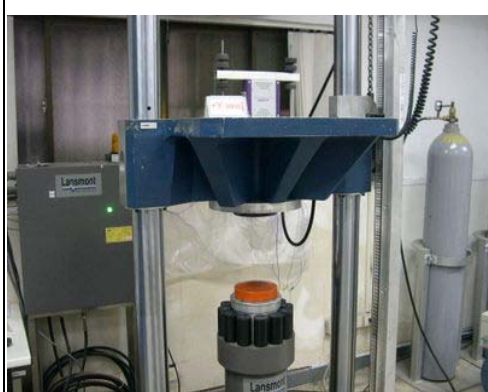
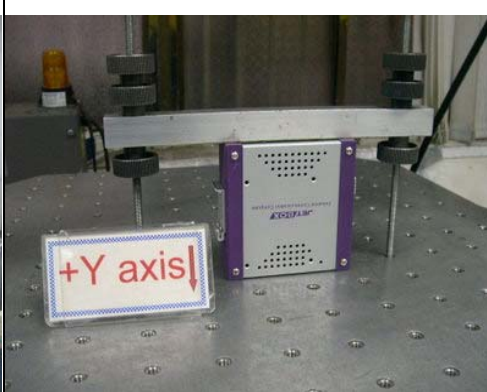
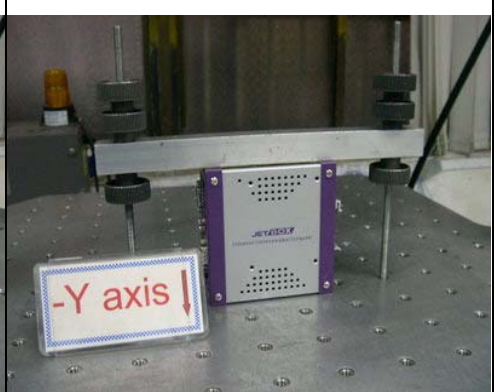
<p>7.Mechanical Shock test: $\pm Y$ axis</p>	<p>8.Mechanical Shock test: +Y axis</p>	<p>9.Mechanical Shock test: -Y axis</p>

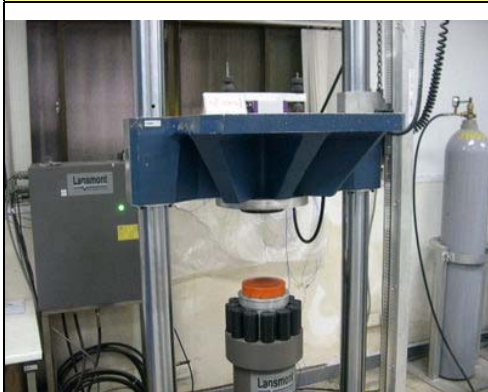
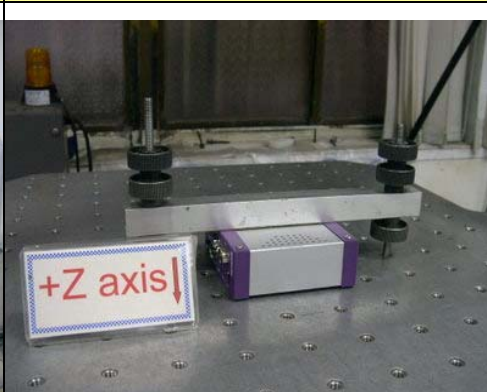
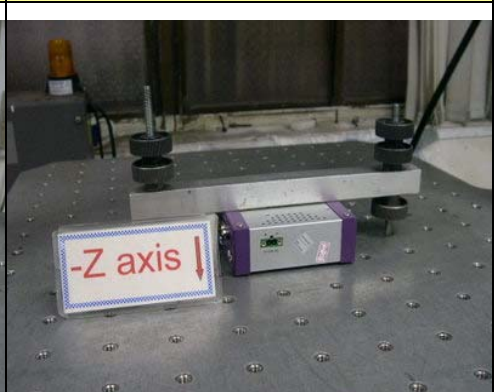
<p>10.Mechanical Shock test: $\pm Z$ axis</p>	<p>11.Mechanical Shock test: +Z axis</p>	<p>12.Mechanical Shock test: -Z axis</p>
