Test Report

EN 50155: 2007

(Clause 12.2.11 Vibration, shock and bump test)

Product : **Ethernet Switching Hub**

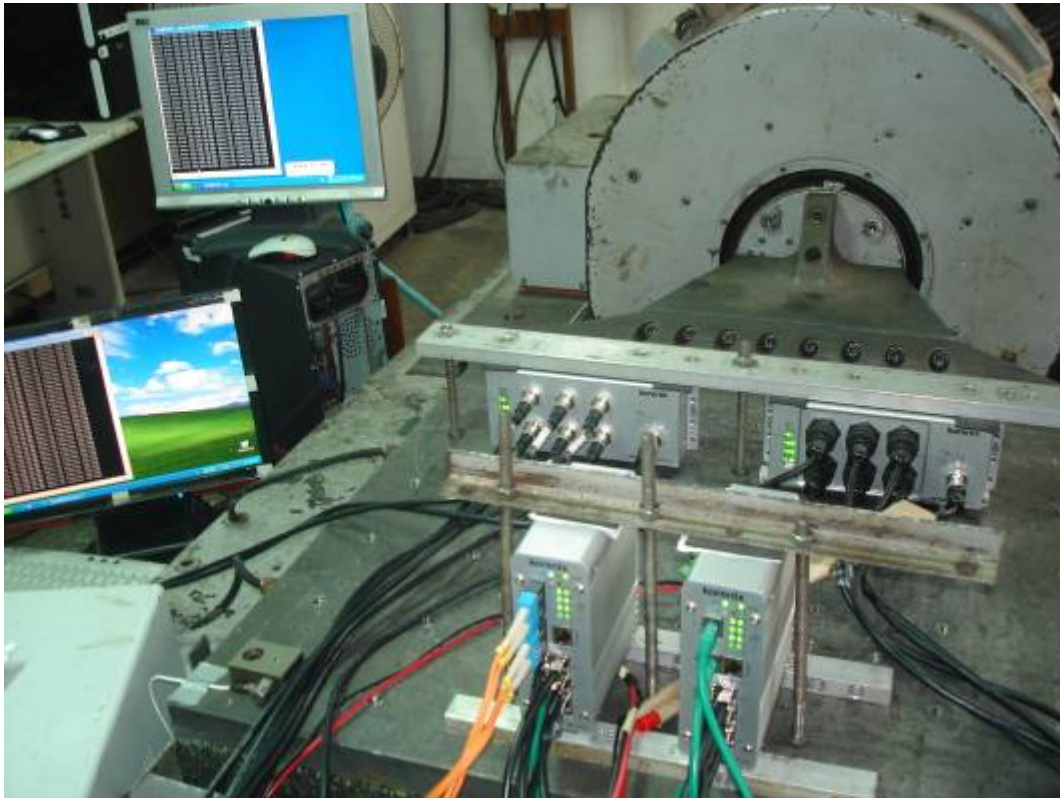
Fig. 1: Vibration Test in X-Axis

1. Test configurations are shown in Fig.1~Fig.3.
2. The testing data are shown in Fig.4~Fig.6.
3. Test specimen was visually inspected after test. No external physical damage was noted.
4. The function of specimen was normal during and after the vibration test.

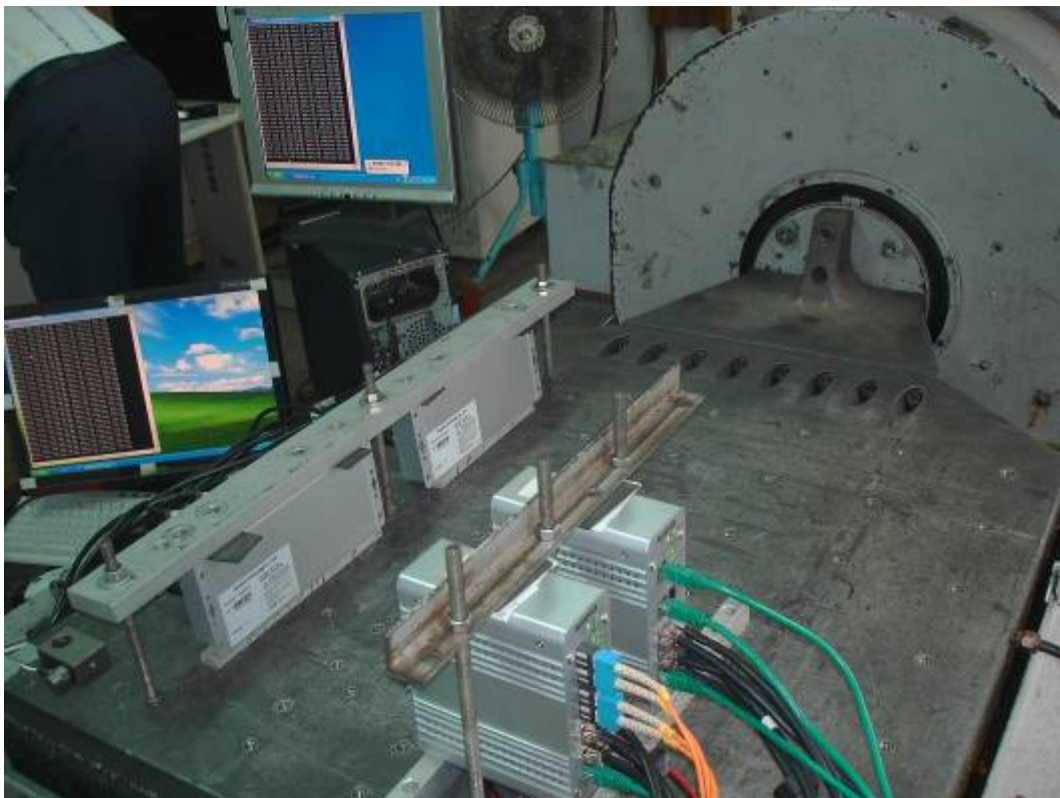
Fig. 2: Vibration Test in Y-Axis

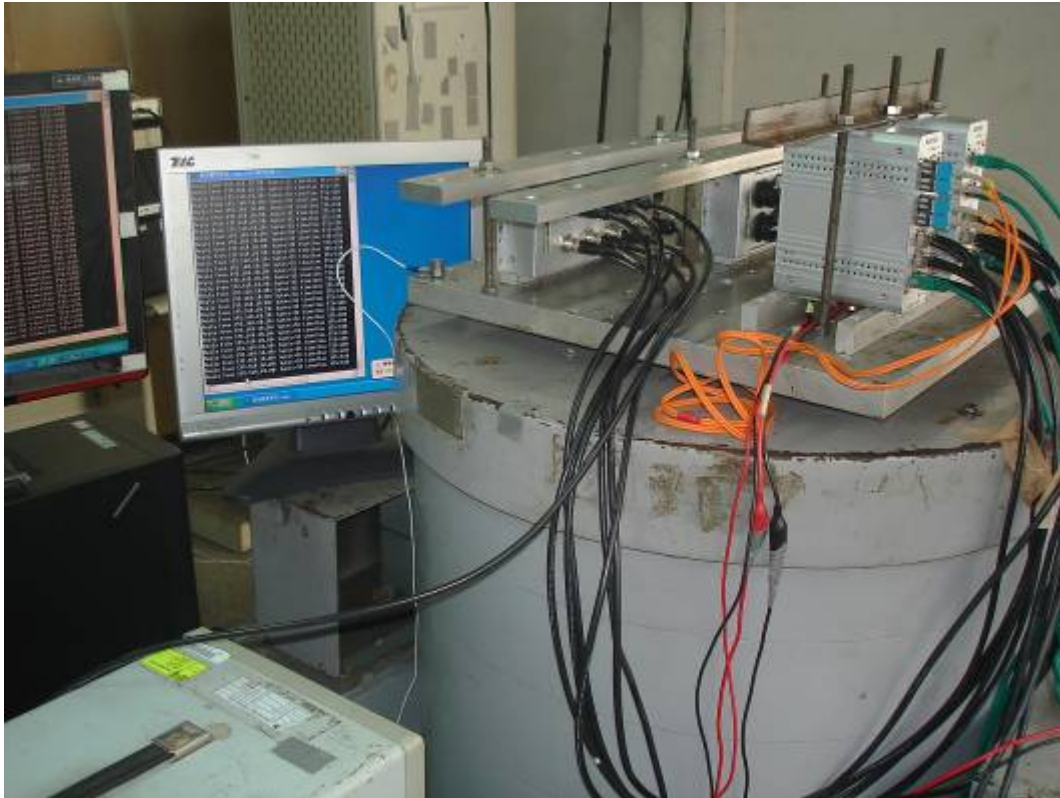
Fig. 3: Vibration Test in Z-Axis

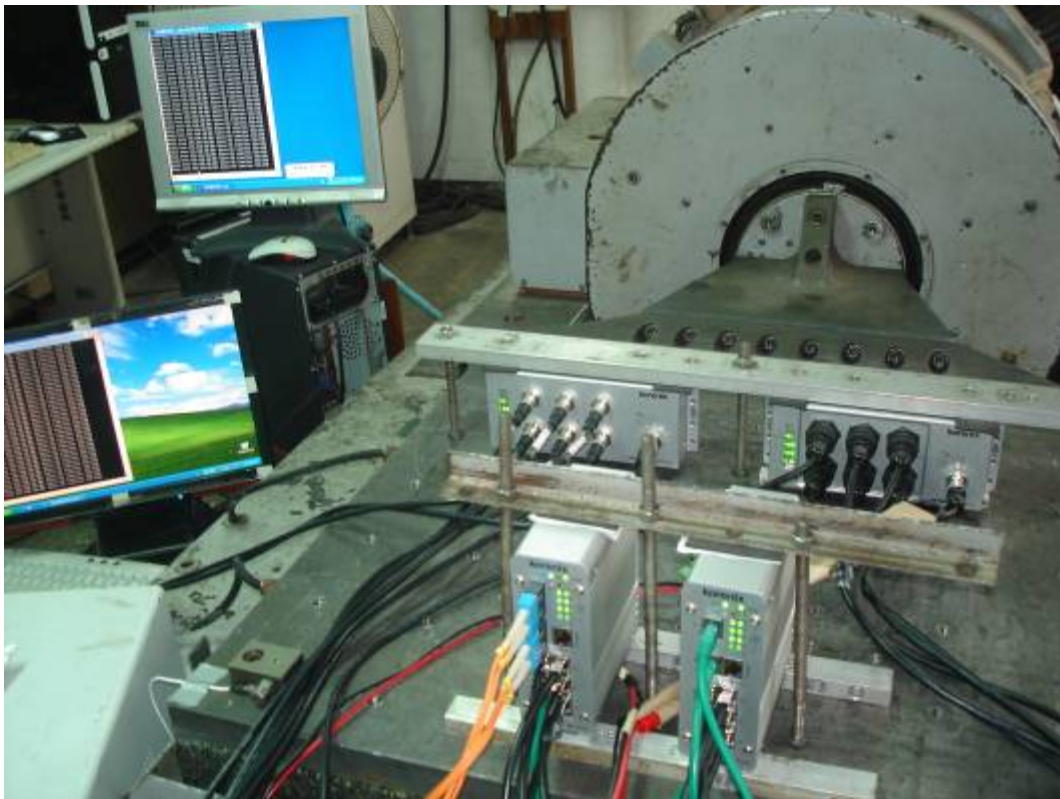
Fig. 1: Increased Vibration test in X-Axis

1. Test configurations are shown in Fig.1~Fig.3.
2. The testing data are shown in Fig.4~Fig.6.
3. Test specimen was visually inspected after test. No external physical damage was noted.
4. The function of specimen was normal after the increased vibration test.

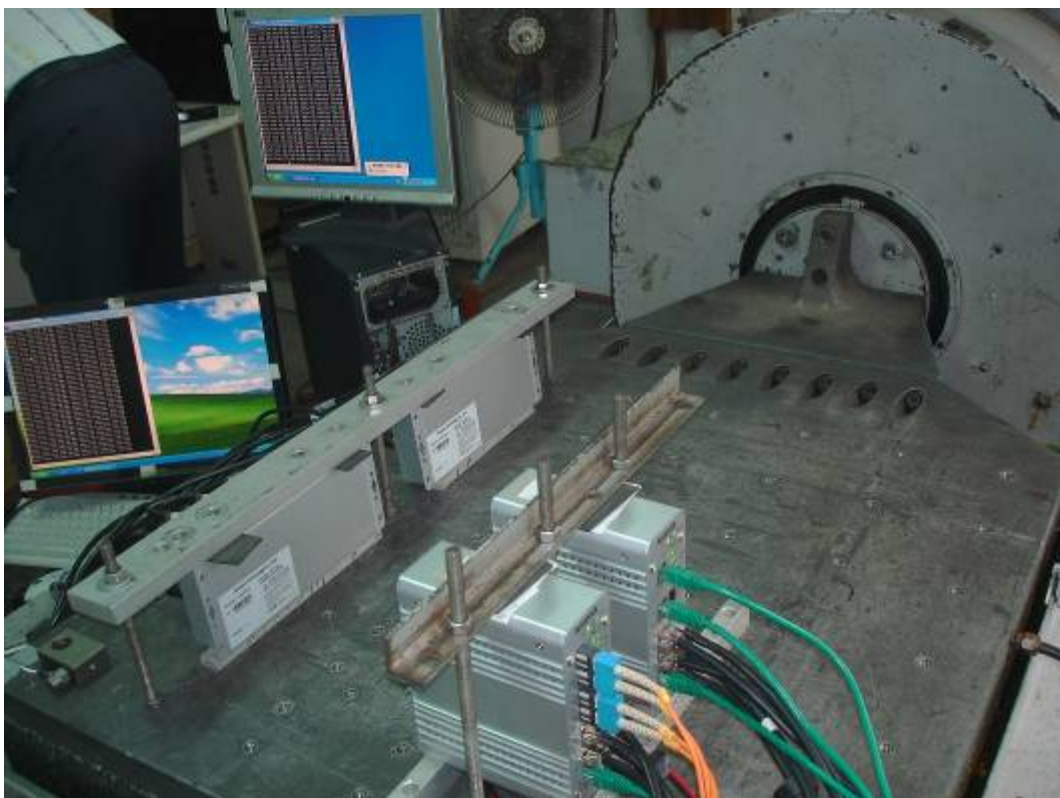
Fig. 2: Increased Vibration test in Y-Axis

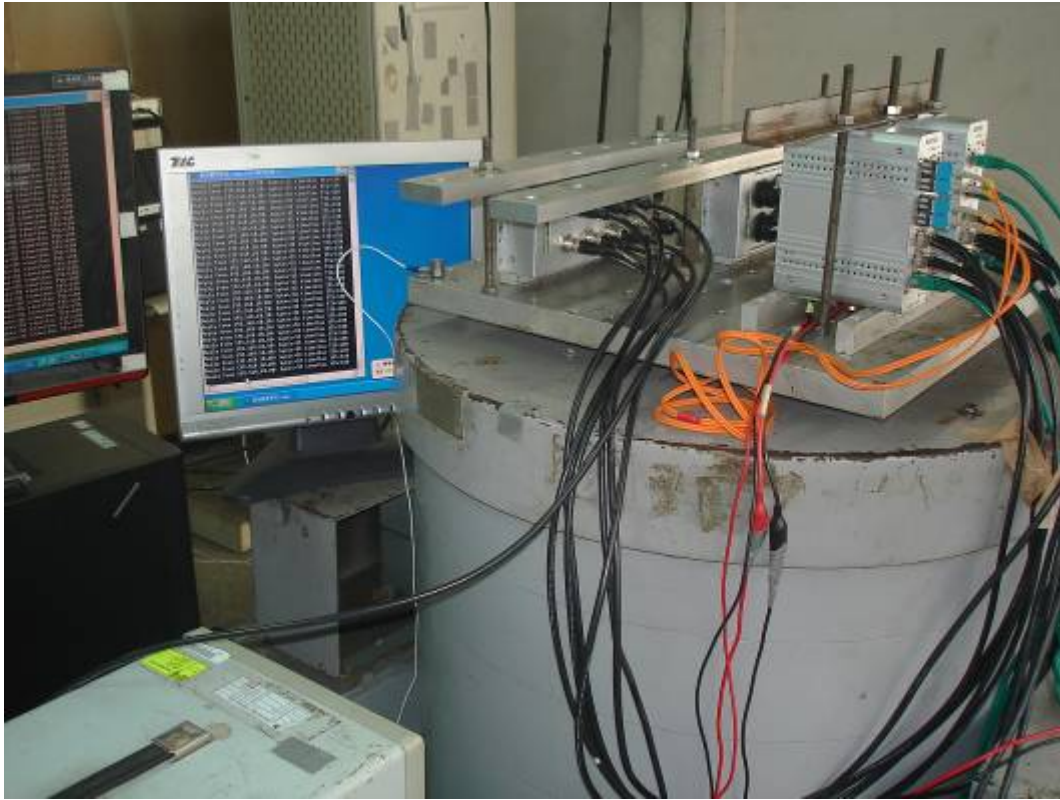
Fig. 3: Increased Vibration test in Z-Axis

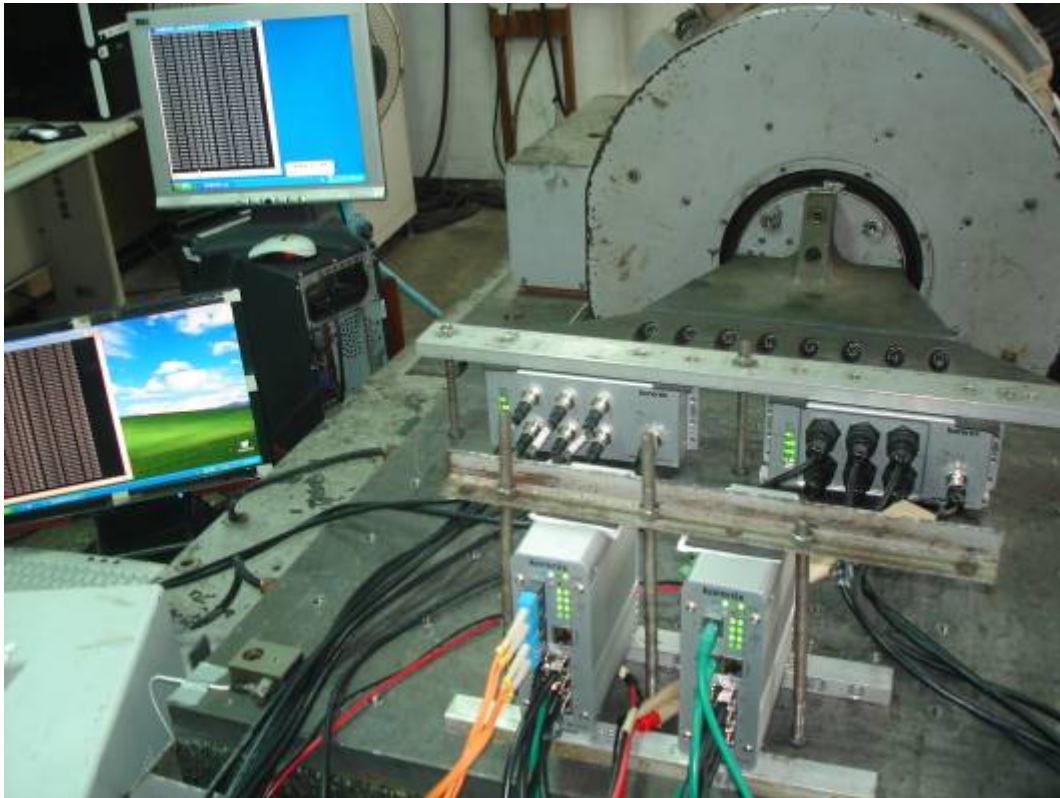
Fig. 1: Shock Test in X-Axis

1. Test configurations are shown in Fig.1~Fig.3.
2. The testing data are shown in Fig.4~Fig.9.
3. Test specimen was visually inspected after test. No external physical damage was noted.
4. The function of specimen was normal during and after the shock test.

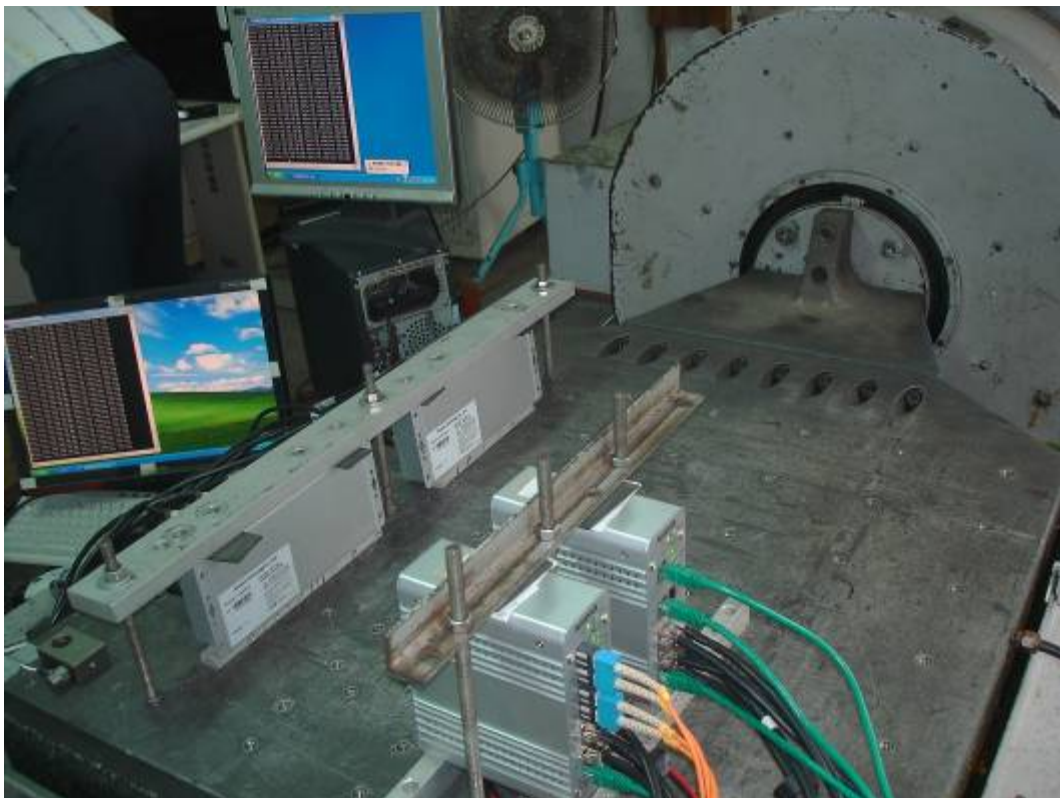
Fig. 2: Shock Test in Y-Axis

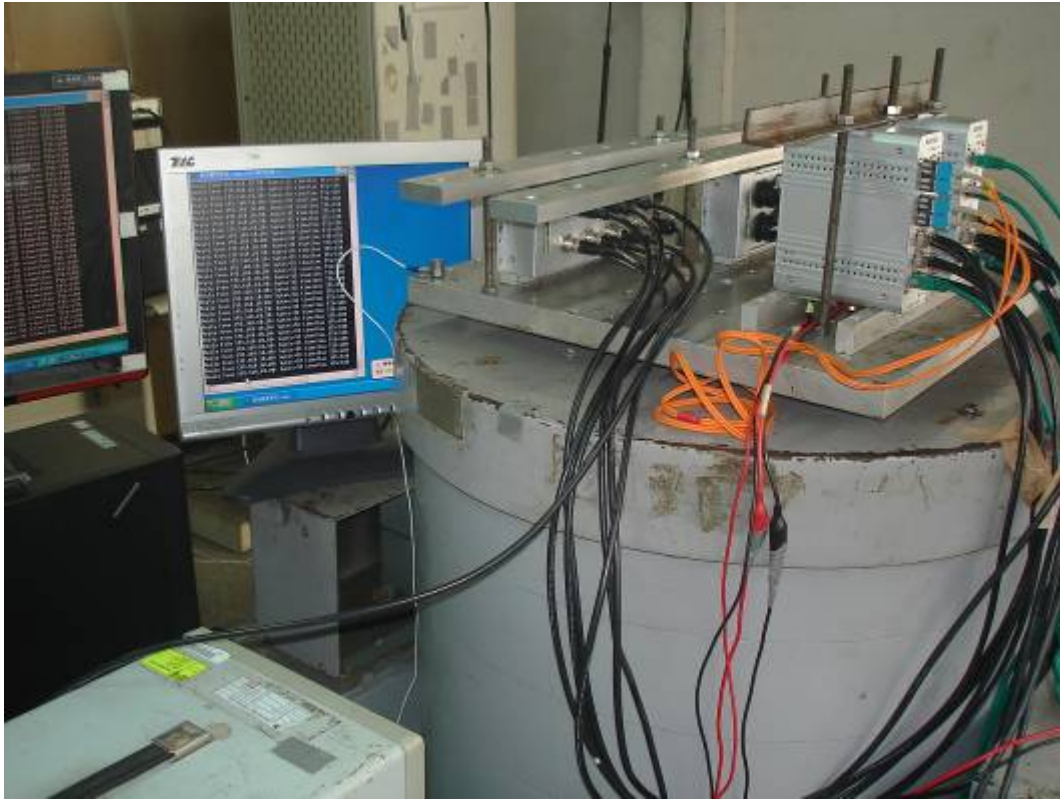
Fig. 3: Shock Test in Z-Axis
