Test Report

EN 50155: 2007

(Clause 12.2.11 Vibration, shock and bump test)

Product : **Ethernet Switching Hub**

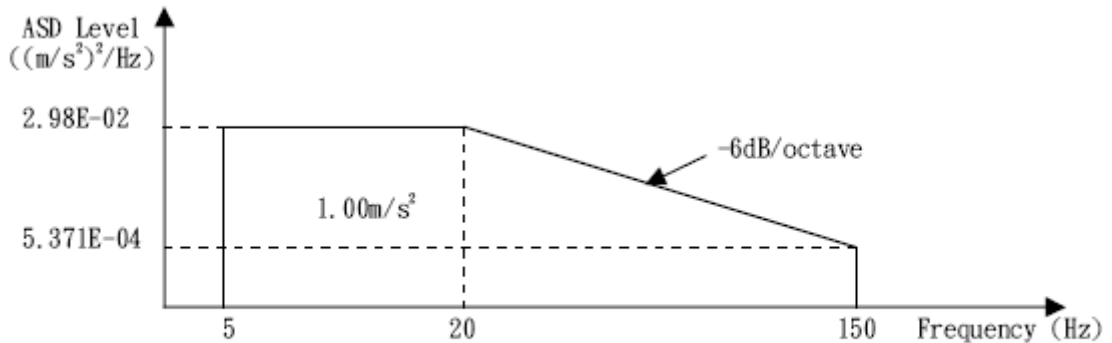
PSD of Vertical (Z) Axis

G_{rms} value: Vertical (Z-Axis) 1.00m/s^2

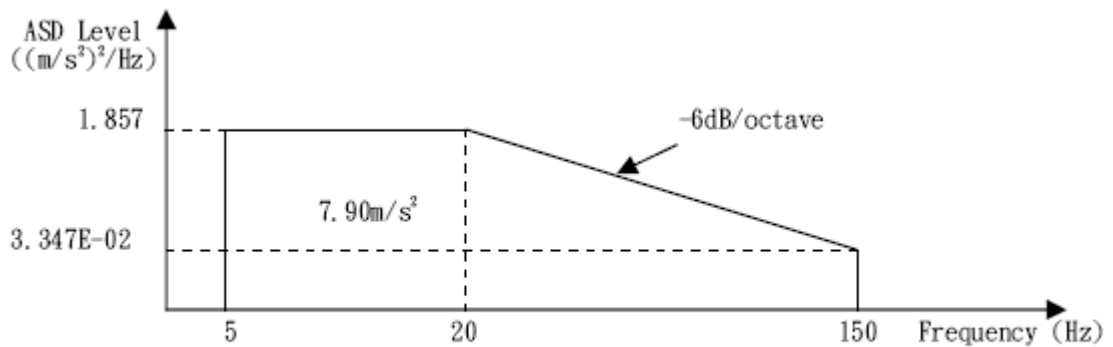
PSD of Vertical (Z) Axis

G_{rms} value: Vertical (Z-Axis) 7.90m/s^2

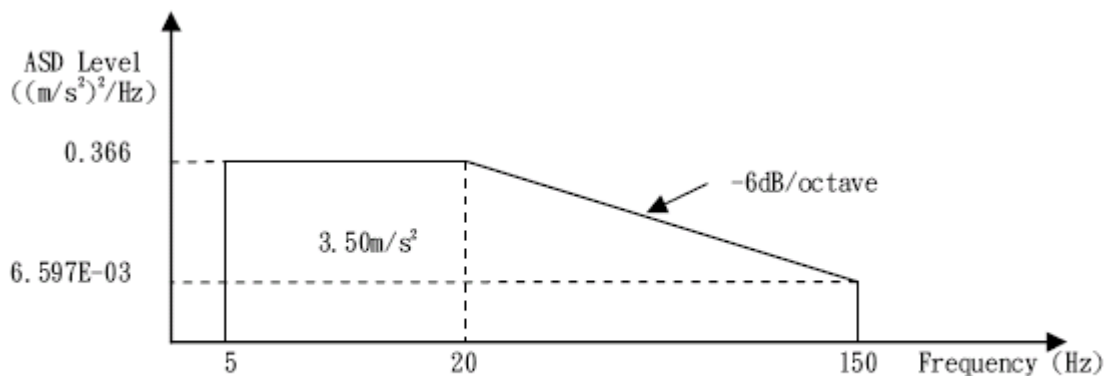
PSD of Transverse (Y) Axis

Transverse (Y-Axis) 3.50m/s^2

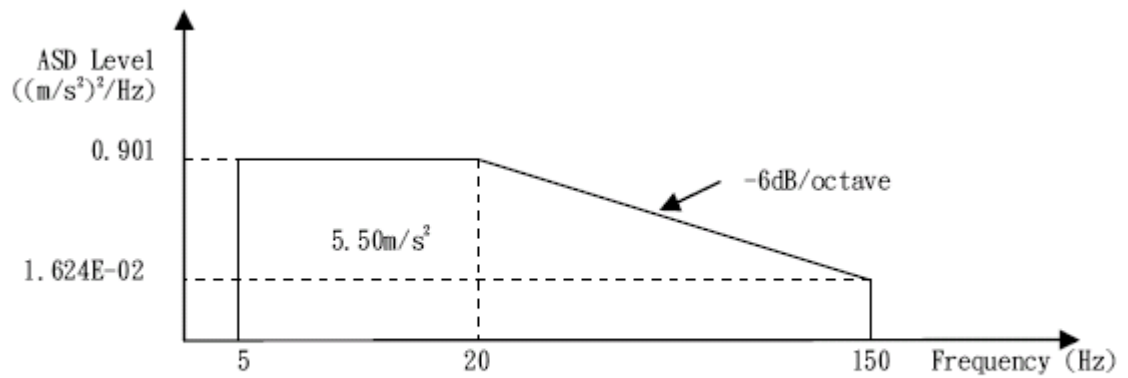
PSD of Longitudinal (X) Axis

Longitudinal (X-Axis) 5.50m/s^2

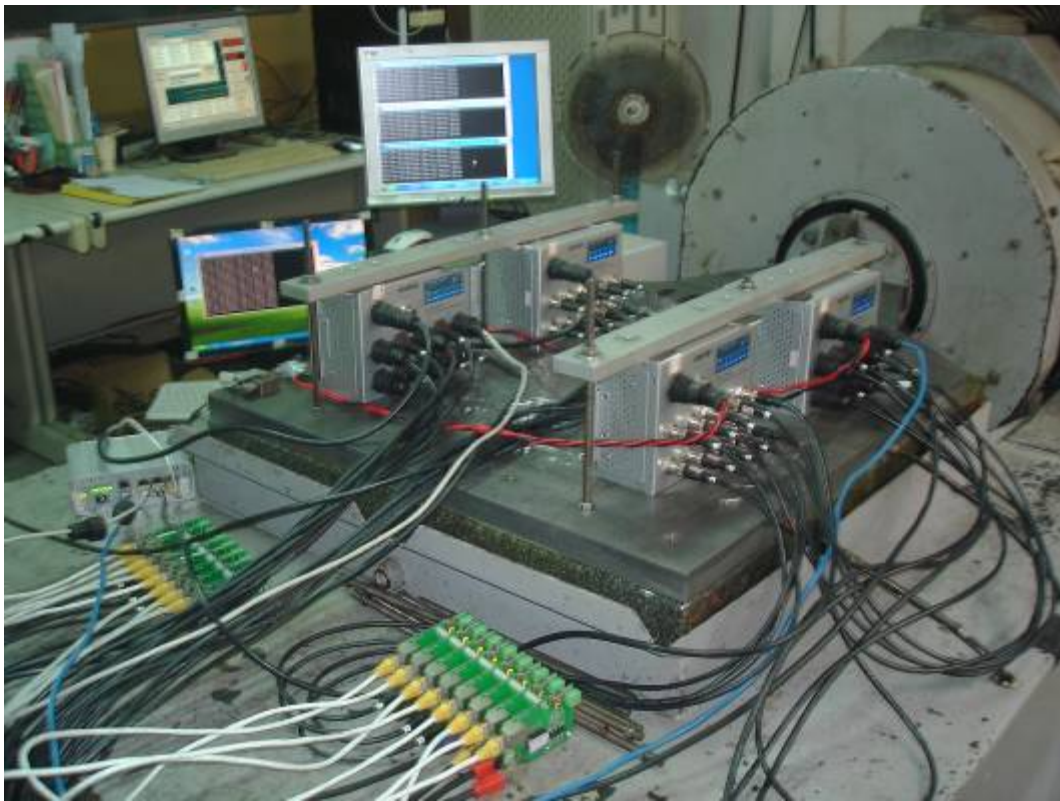
Fig. 1: Increased Vibration test in X-Axis

1. Test configurations are shown in Fig.1~Fig.3.
2. The testing data are shown in Fig.4~Fig.6.
3. Test specimen was visually inspected after test. No external physical damage was noted.
4. The function of specimen was normal after the increased vibration test.

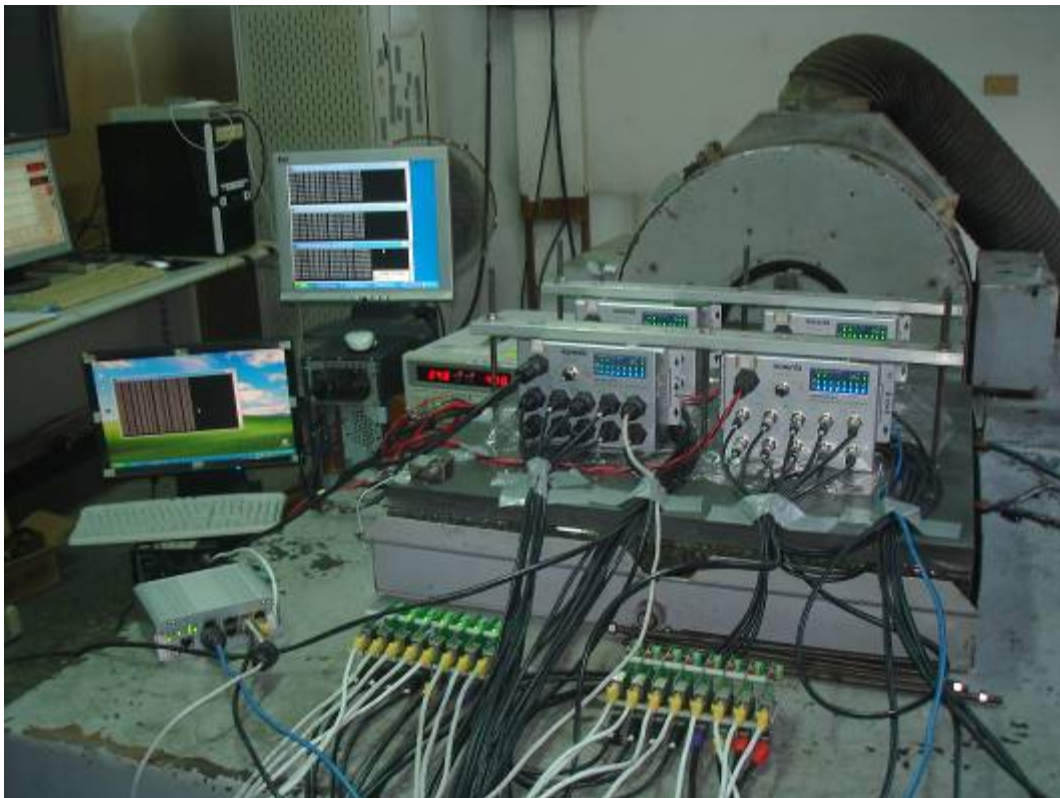
Fig. 2: Increased Vibration test in Y-Axis

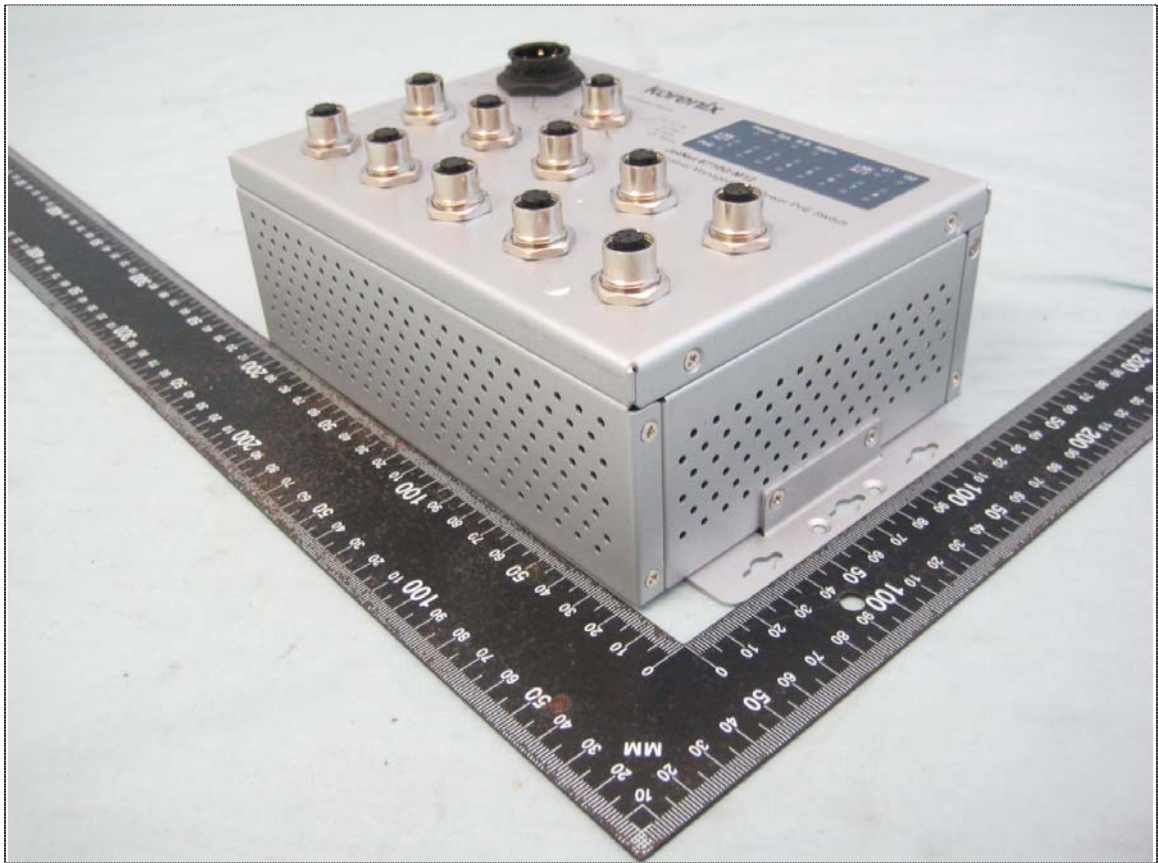
Front View of EUT

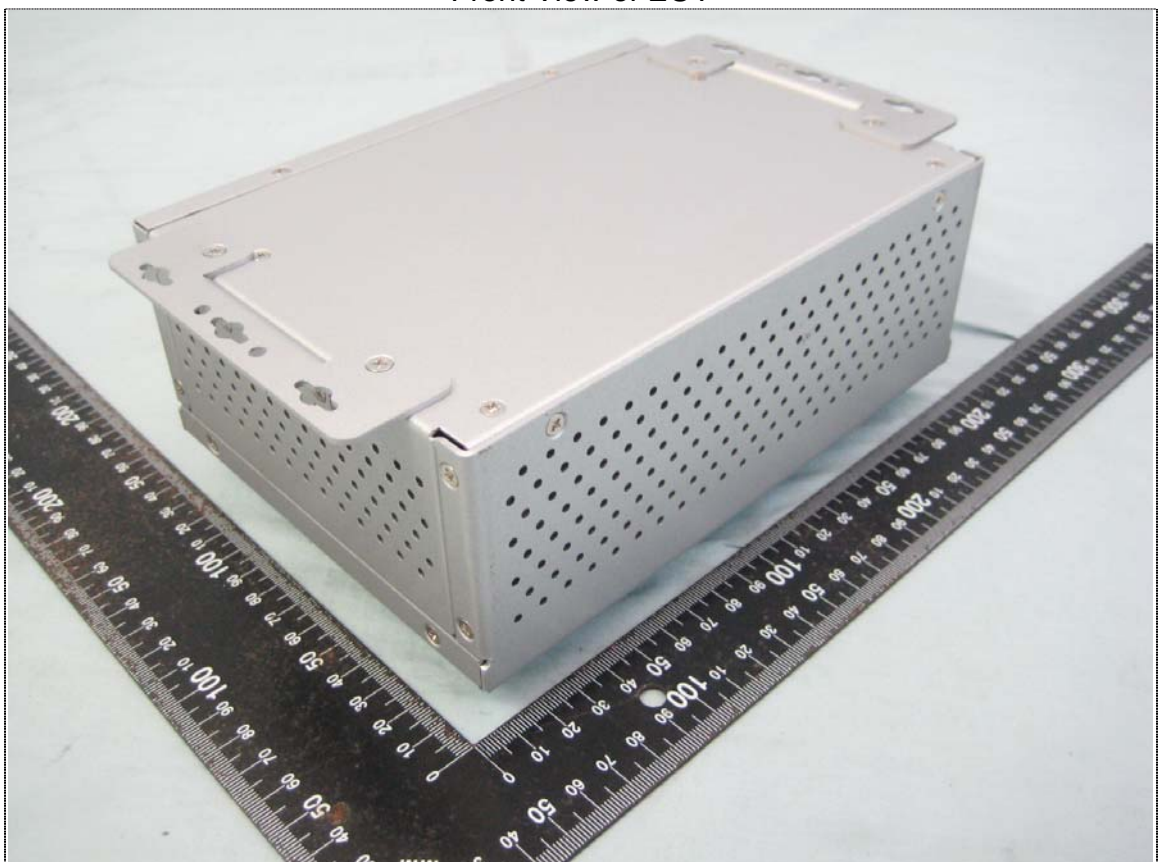
Rear View of EUT
