Test Report

EN 50155: 2007

(Clause 12.2.11 Vibration, shock and bump test)

Product : **Ethernet Switching Hub**

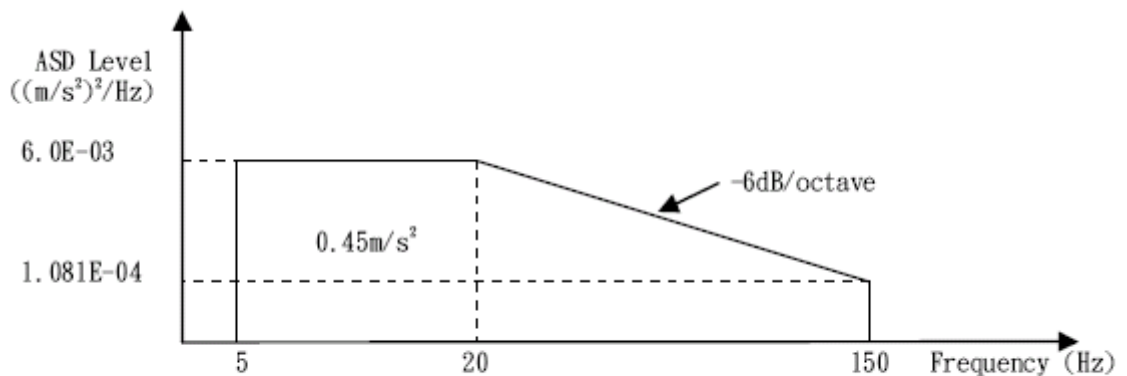
Transverse (Y-Axis) 0.45m/s^2

PSD of Transverse (Y) Axis

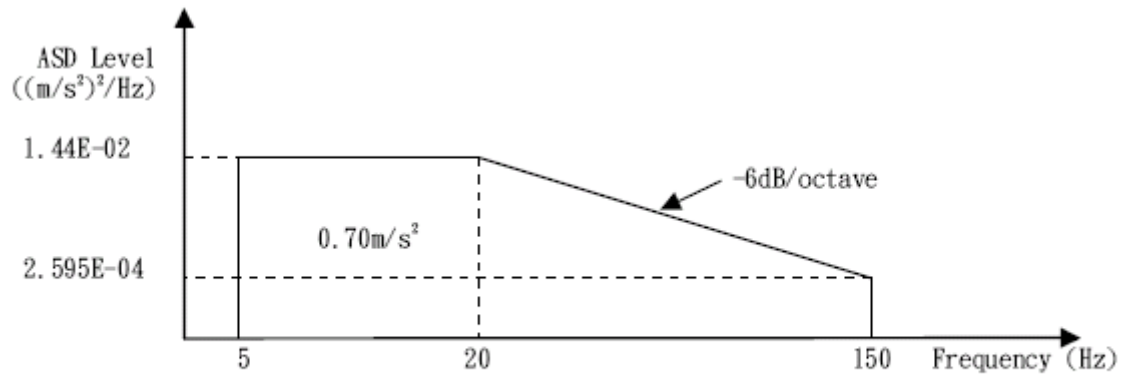
Longitudinal (X-Axis) 0.70m/s^2

PSD of Longitudinal (X) Axis

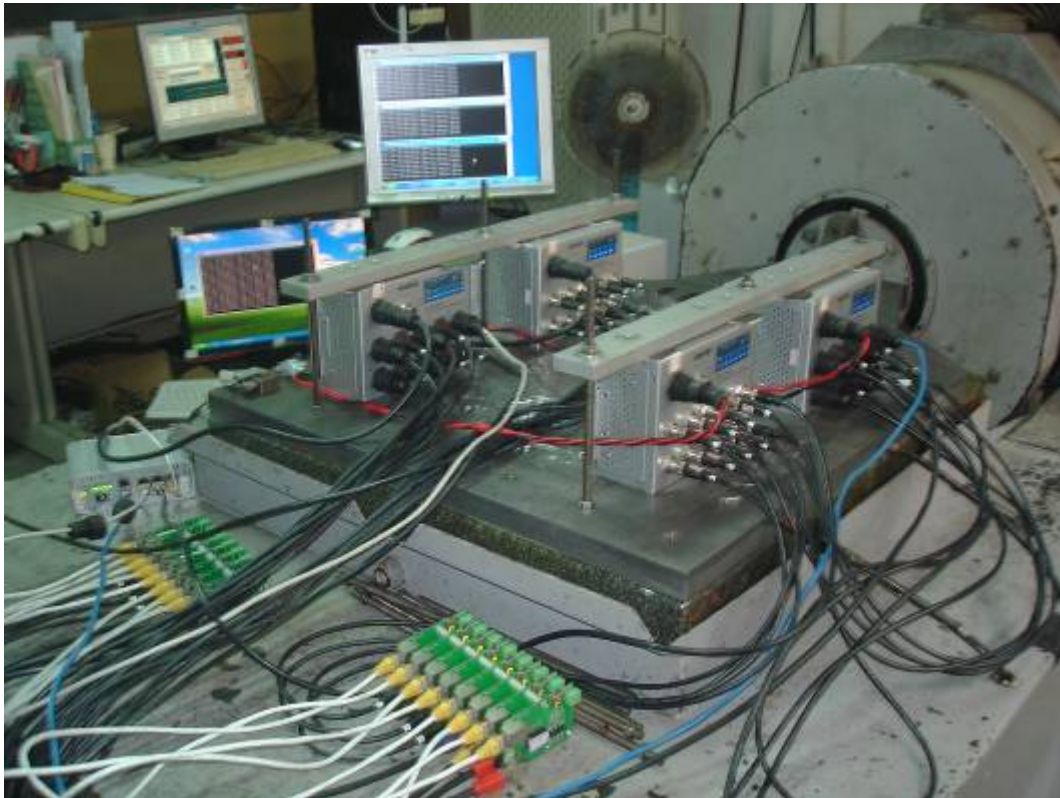
Fig. 1: Vibration Test in X-Axis

1. Test configurations are shown in Fig.1~Fig.3.
2. The testing data are shown in Fig.4~Fig.6.
3. Test specimen was visually inspected after test. No external physical damage was noted.
4. The function of specimen was normal during and after the vibration test.

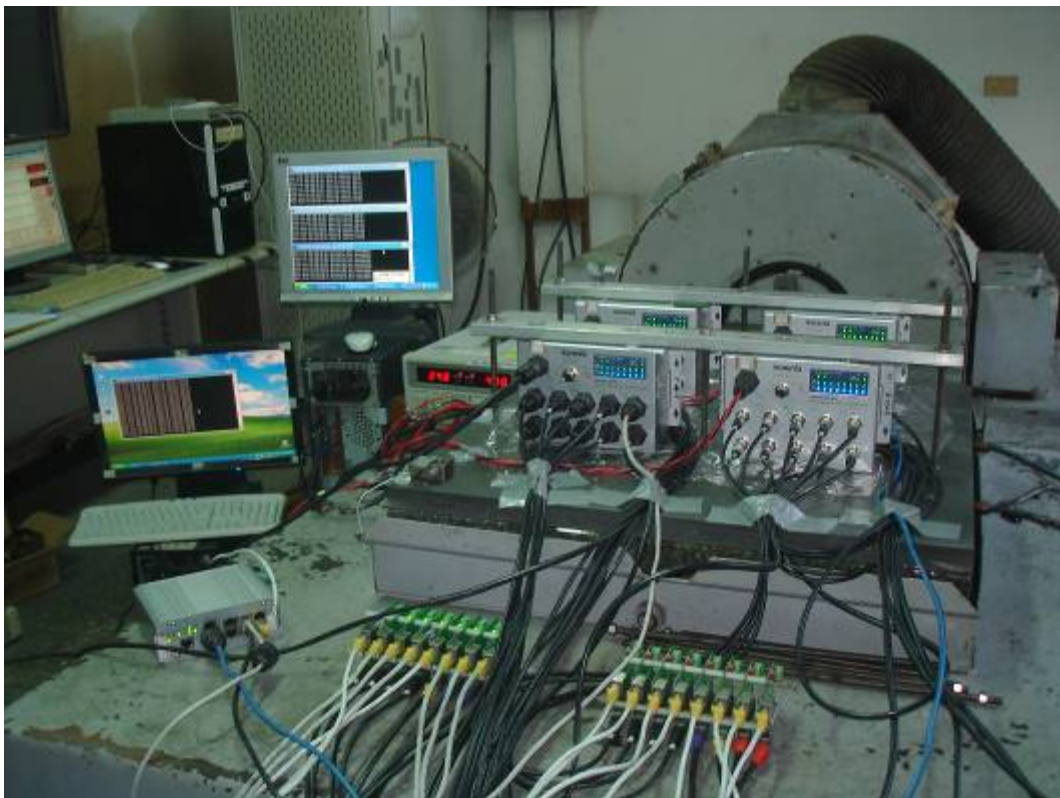
Fig. 2: Vibration Test in Y-Axis

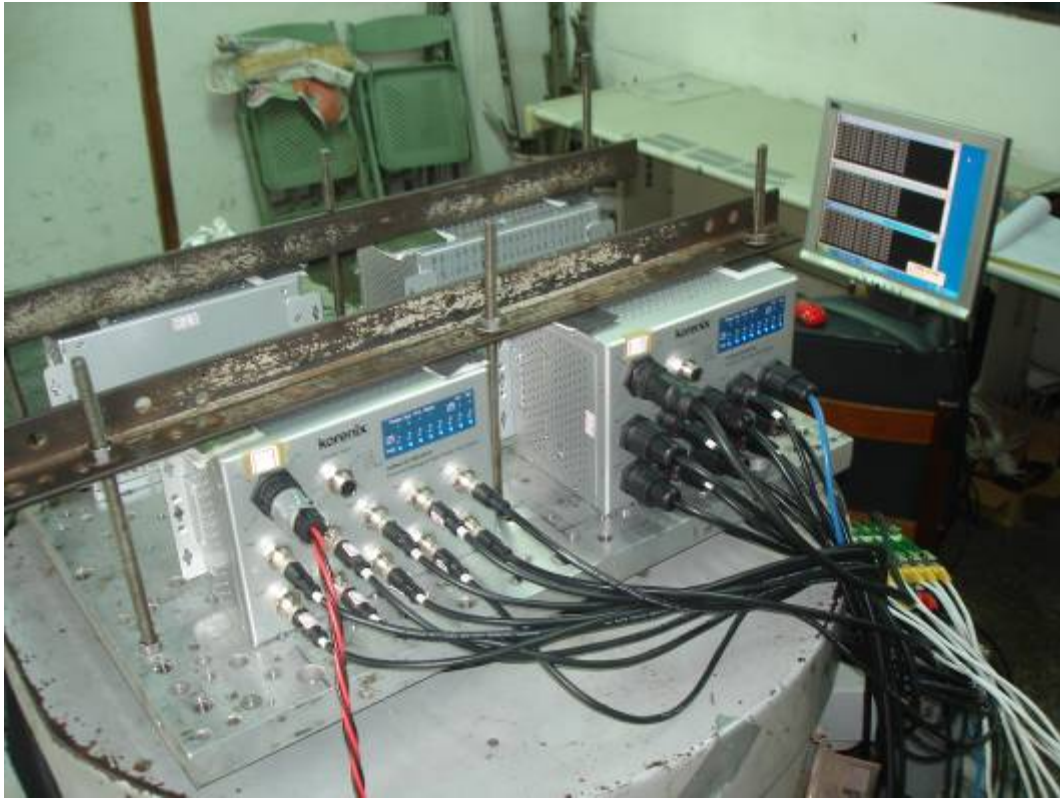
Fig. 3: Vibration Test in Z-Axis

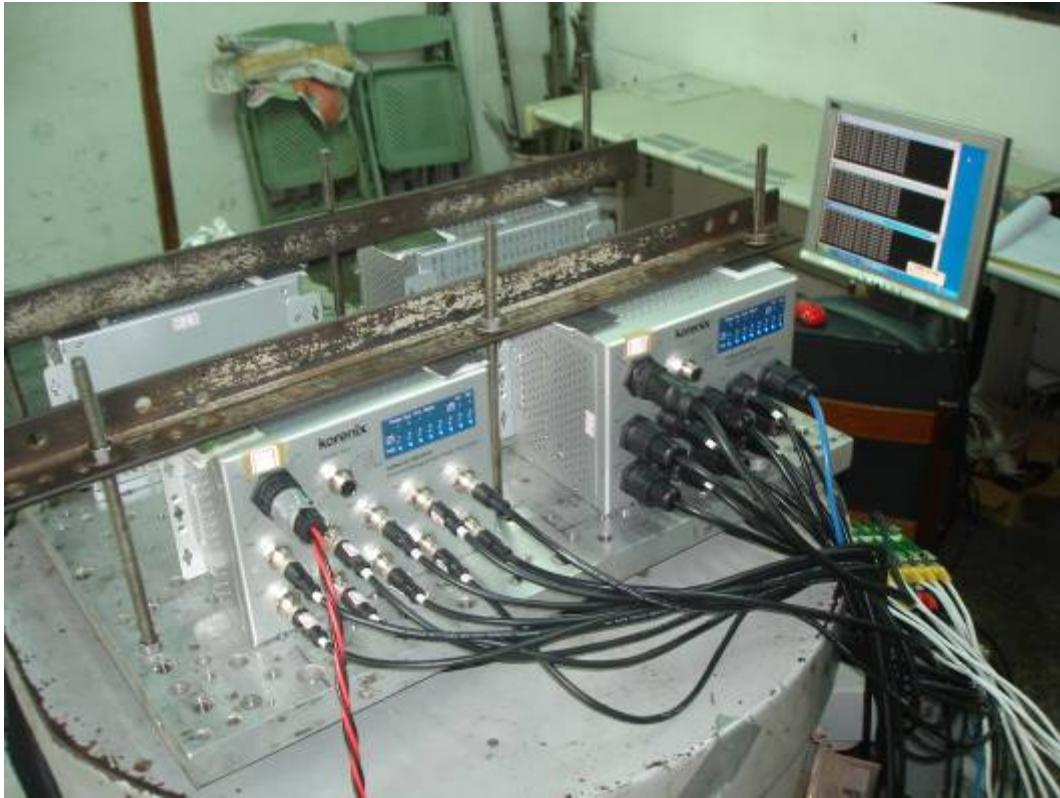
Fig. 3: Increased Vibration test in Z-Axis

1. Test configurations are shown in Fig.1~Fig.3.
2. The testing data are shown in Fig.4~Fig.6.
3. Test specimen was visually inspected after test. No external physical damage was noted.
4. The function of specimen was normal after the increased vibration test.

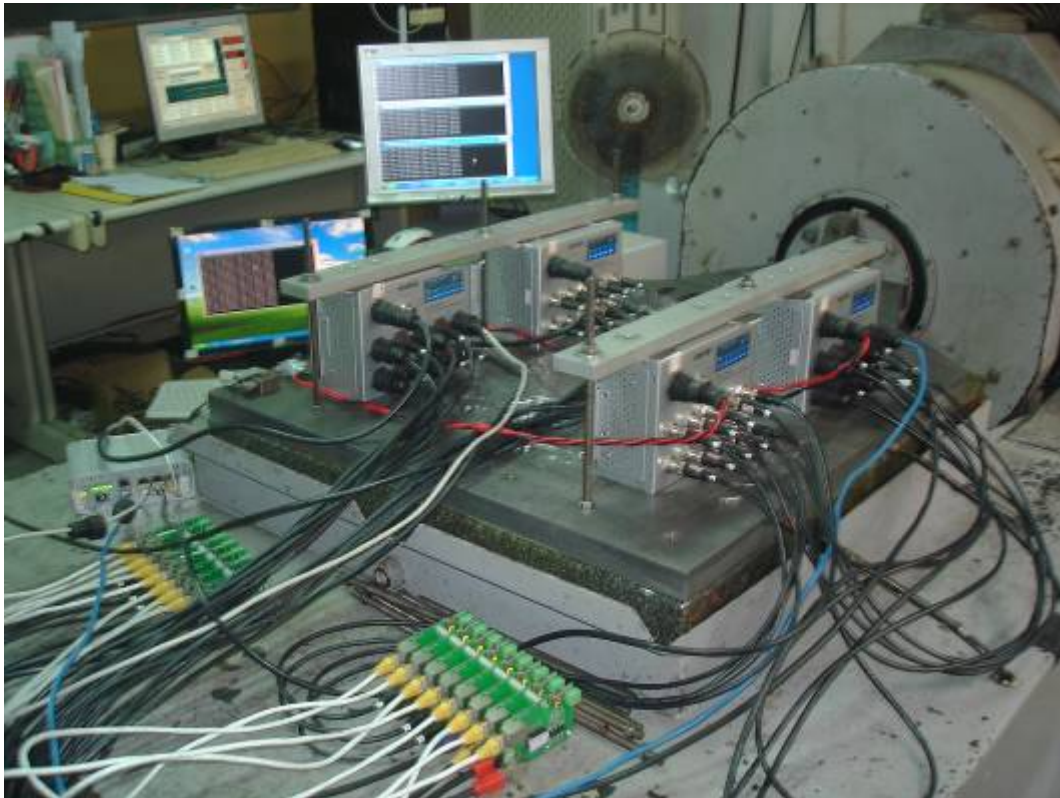
Fig. 1: Shock Test in X-Axis

1. Test configurations are shown in Fig.1~Fig.3.
2. The testing data are shown in Fig.4~Fig.9.
3. Test specimen was visually inspected after test. No external physical damage was noted.
4. The function of specimen was normal during and after the shock test.

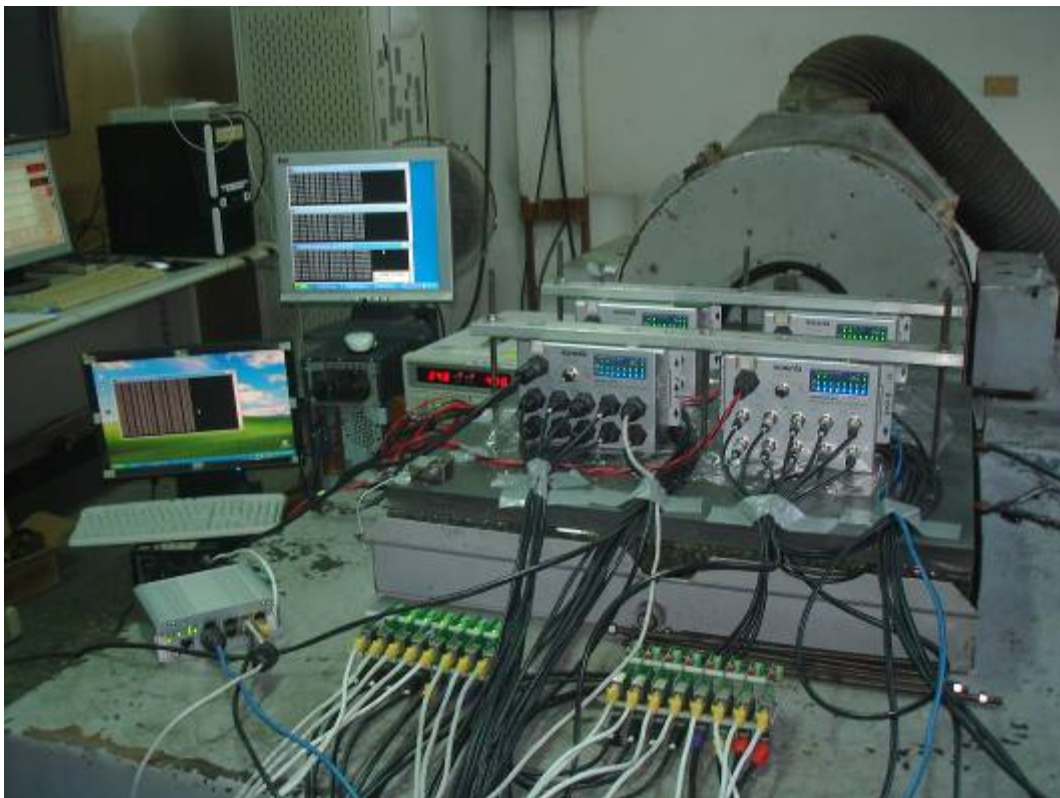
Fig. 2: Shock Test in Y-Axis

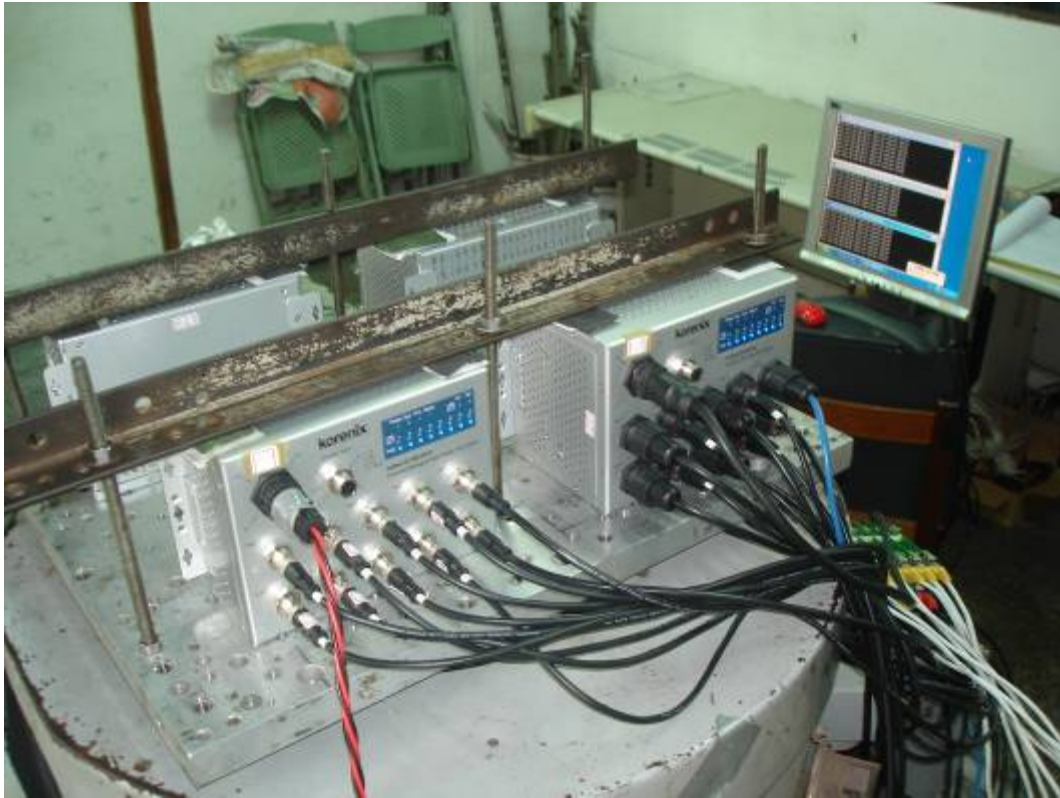
Fig. 3: Shock Test in Z-Axis

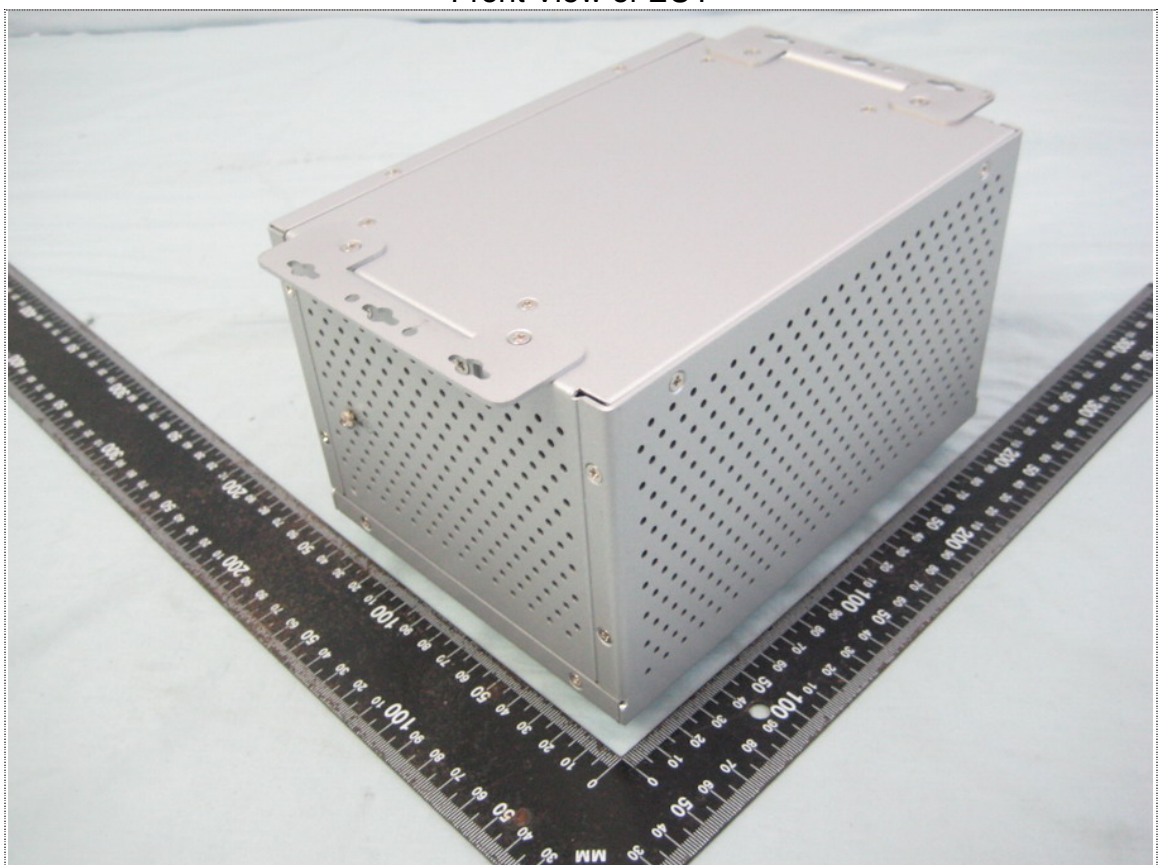
Rear View of EUT
